FRONT GRILLE UPPER/LOWER ACTIVE AIR FLAPS: LTD WTY EXT TO 15 YEARS/150,000 MILES

This Service Information bulletin (Revision 06) supersedes SI B01 12 19 **dated August 2021**

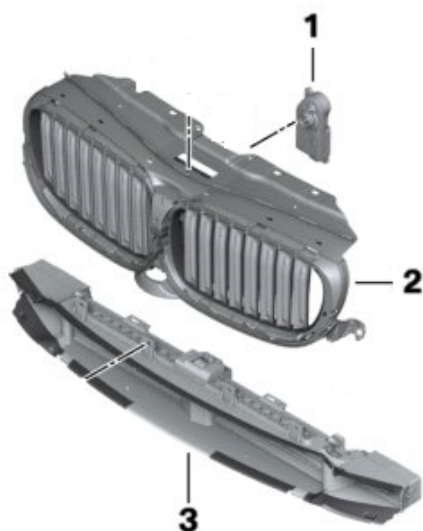
1. Air flap control (link) active, upper (G12, G30 and G32)
2. Air flap control (drive), active, upper
3. Air flaps, upper (assembly)
4. Air flaps, lower (assembly)
