**SIDE PANEL REAR LIGHT HOUSINGS: LTD WTY EXT TO 10 YEARS
WITHOUT MILEAGE LIMIT**

Please see SI B01 13 19 (DC 63 21 90 01 00). For this vehicle, the side panel tail lamp housing mounting tabs limited warranty for defects in materials or workmanship has been extended to 10 years without mileage limit as determined from the original in-service date. This coverage is subject to the same vehicle eligibility requirements, limitations, and exclusions that apply to the BMW New Vehicle Limited Warranty for Passenger Cars and Light Trucks.

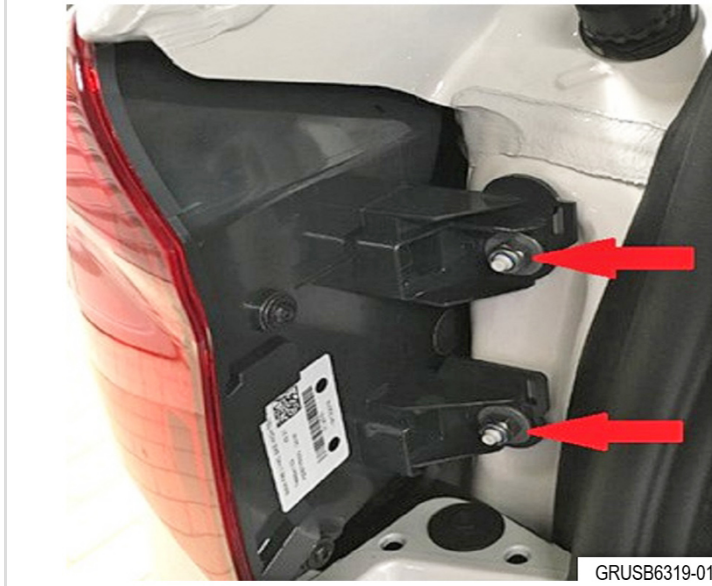
The rear light housing(s) can loosen/detach at the mounting tabs, this can cause a clacking sound in the rear of the vehicle while driving.

The plastic mounting tabs for the rear tail light assembly housing(s) may become too brittle and crack to the point where the hold down nut(s) can no longer keep the housing(s) in place.

Replace the rear tail light assembly (left, right or both) that are found to have cracked and broken Housing Mounting Tabs.
