BMW REMOTE SOFTWARE UPGRADE IS NOT OFFERED FOR INSTALLATION

This Service Information Bulletin (Revision 2) replaces SI B09 01 20 **dated December 2020**.

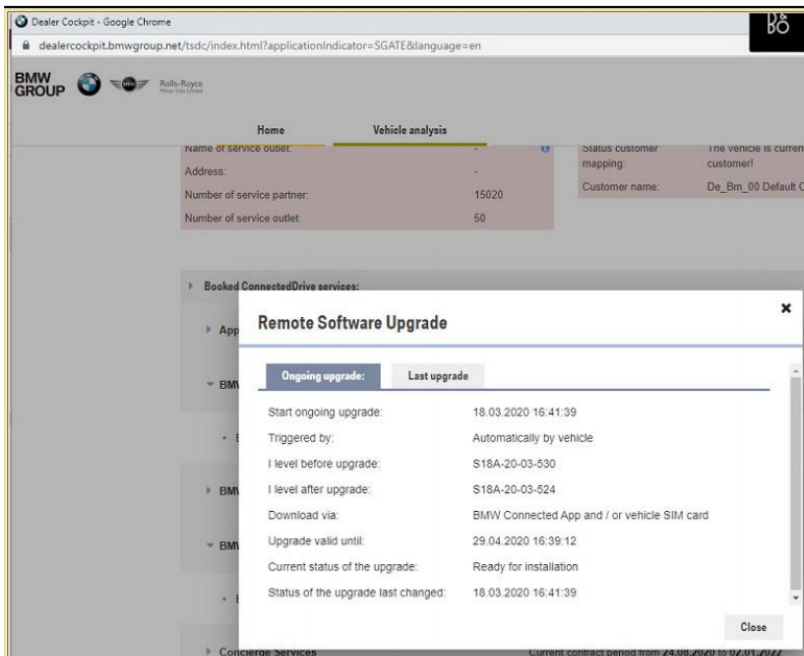
Step1: Check the basic Remote Software Upgrade capability, either in the Dealer Cockpit as shown in figure 1 or in the vehicle menu: Menu à General settings à Remote Software Upgrade is displayed.

Figure 1: RSU status in the Dealer Cockpit Application

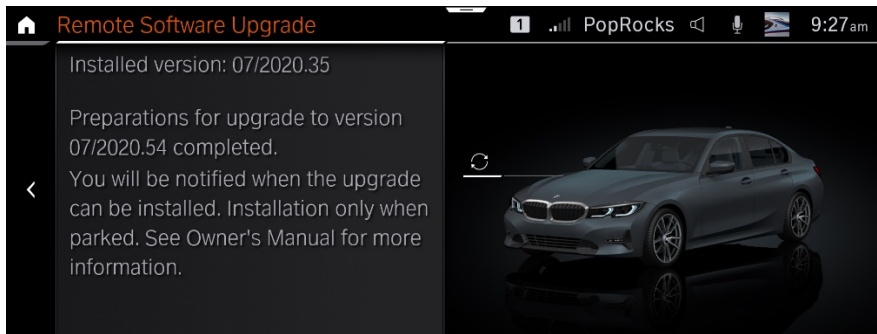
Figure 2: RSU status in the vehicle menu

Step 2: Check the upgrade offering:
 Either in the Dealer Cockpit (figure 1) or in the vehicle under Menu à General settings à BMW Remote Software Upgrade (figure 2), check whether an upgrade is currently offered for this vehicle:

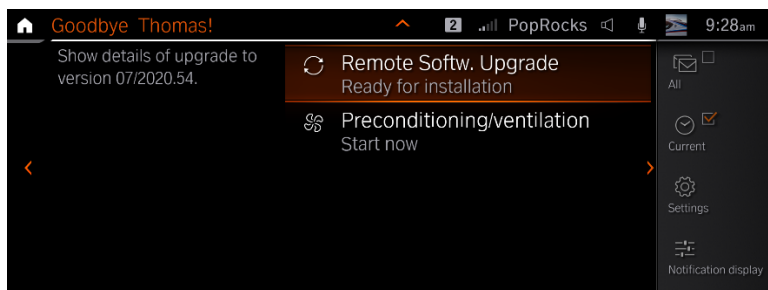
- Exit the diagnostic mode completely, then carry out a test drive for at least 1 minute at a speed greater than 7 mph
- After switching off the engine, observe the instructions in the central information display (CID)
- When the upgrade is running, the “Goodbye Screen” shows Remote Software Upgrade “Preparing”
- When the download is completed in the Goodbye Screen, the Menu is shown Remote Software Upgrade “Ready for installation” as shown in the screen below

Figure 3: Remote Software Upgrade ready for installation in Goodbye Screen
