**RECALL 22V-119: POSITIVE CRANKCASE VENTILATION (PCV) BLOW-BY HEATER**

This Service Information Bulletin (Revision 4) replaces SI B11 01 22 **dated July 2022**.

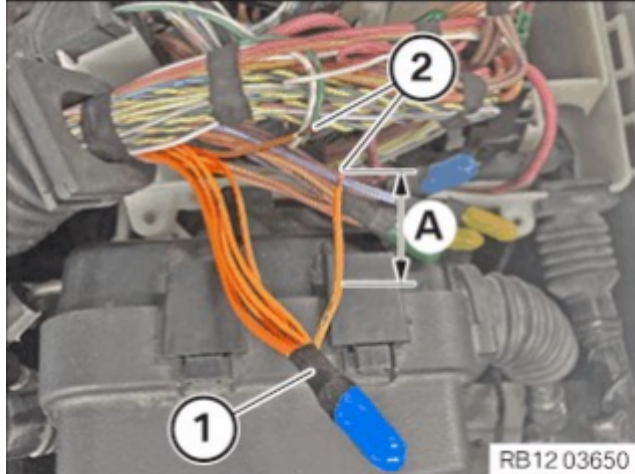
Repair Instruction 00 72 067 “Retrofitting component protection and checking function of angle fitting” indicates the splice cap is blue, this is not the actual color of the splice cap.

The picture has been edited to highlight the splice cap with blue coloring (1).
