MODEL

G30 (5 Series 540dX)	
----------------------	--

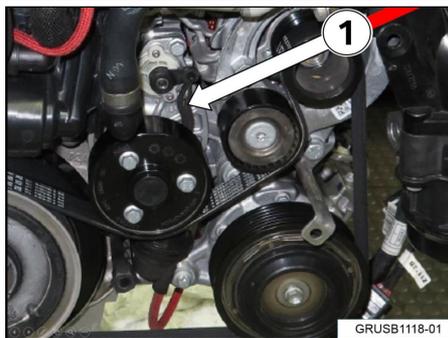
The changeover valve (1) for the coolant pump is binding.

Check the operation of the changeover valve and if necessary, replace the coolant pump.
