| E53, E60, E63, E64, E65, E66 with N62 from Series introduction up to 06/30/2004 |

In order to remedy the situation, BMW is conducting a Voluntary Emissions Recall Campaign to replace crankcase ventilation valves on all affected vehicles.

**N62 Crankcase Ventilation Valve Replacement**

**CAMPAIGN NO. 06E-A02**

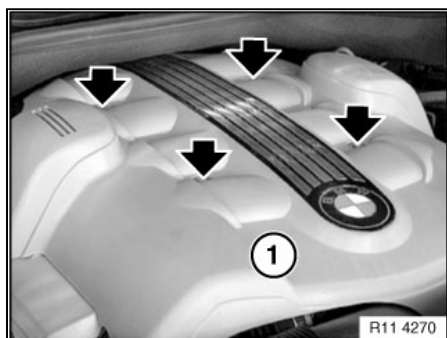
Remove the 4 screws securing the acoustic cover (1) to the engine. Remove towards the front.

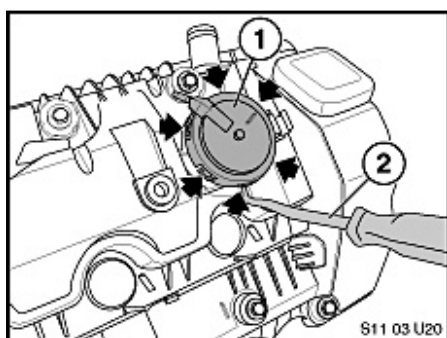
Remove the trim covers from both valve covers to expose the crankcase vent valves (1). Using a pick (2), release the six clips securing the vent valve.

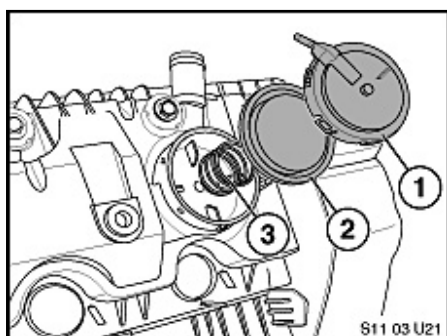
Remove the vent valve cover (1), diaphragm (2), and spring (3). The replacement repair kit consists of all three parts. Install in the reverse order ensuring that the cover is in the correct position (see illustration) and that all six clips are securely and positively engaged.

On affected vehicles replace the crankcase ventilation valves on both cylinder banks using improved parts (P/N 11 12 7 547 058). Please note that the repair kit contains sufficient parts to repair one crankcase vent valve. To complete this repair procedure, order two valves kits.
