# MODEL

G12 (750Li Sedan) Produced from 5/2015	G12 (ALPINA B7 Sedan) Produced from 12/2015	G30 (M550iX Sedan) Produced from 12/2016
--	---	--

With the N63R engine

## SITUATION

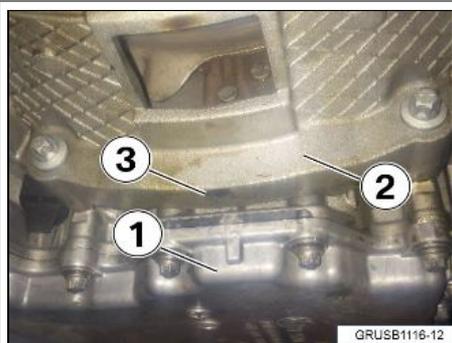
The engine oil will exit the vehicle from between the engine and transmission.

- Engine oil pan (1)
- Transmission bell housing (2)
- Engine oil residue (3)

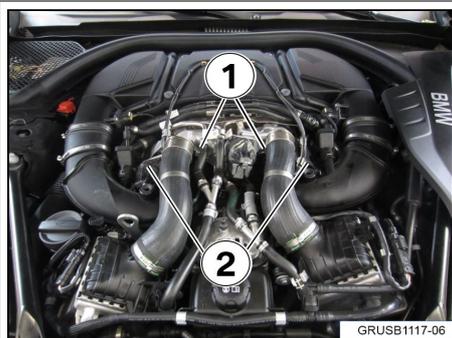
When diagnosing the engine oil leak it is necessary to use a borescope to identify if the source of the leak is coming from under the turbochargers. Insert the borescope to the inside (1) and outside (2) of the induction pipes.

Rotate the borescope 360 degrees to search for any leaks. Try using the bore scope in the strait and 90° viewing positions.

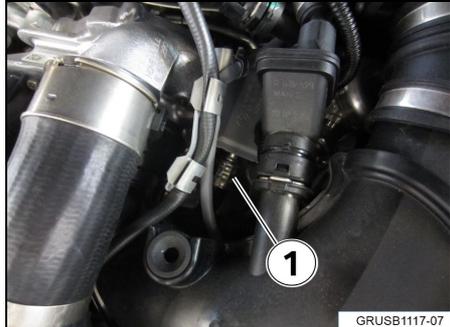
2. Pay special attention to any ferruled or clamped hose connections (1).

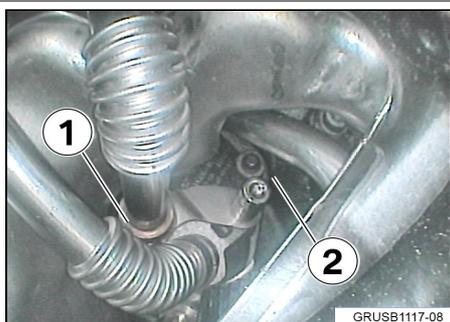
3. Insert the borescope downward towards the turbocharger oil return pipes.

Look for leaking connections (1).  
Also search around the block surface for any standing engine oil (2).

Replace the turbocharger engine oil supply (feed) lines if found leaking.
