**SERVICE ACTION: REPLACE THE MECHANICAL COOLANT PUMP**

This Service Information Bulletin (Revision 3) replaces SI B11 05 21 **dated April 2022**.

This Service Action involves G05, G06, G07, G20, G22, G23 and G30 vehicles produced from September 2020 to May 24, 2021.

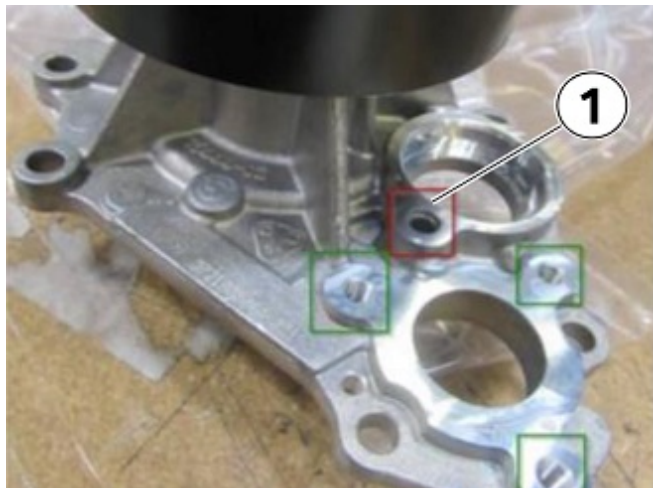
NOTE: The bolt hole for the coolant flange (1) may not be threaded. The self-tapping screw from the original water pump must be re-used.

Follow this tightening sequence (threads or no threads present)

1. Tighten to 12.5 Nm
2. Loosen the screw 360 degrees (one full turn)
3. Tighten the screw again to 12.5 Nm
