## EMISSIONS RECALL 21E-A03: REPLACE THE MAP THERMOSTAT

This Service Information Bulletin (Revision 5) replaces SI B11 12 21 **dated May 2022**.

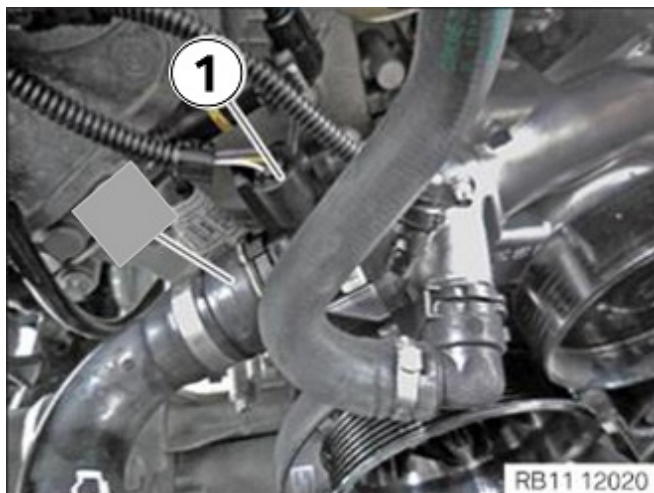
- Unplug the electrical connector from the MAP thermostat (1)

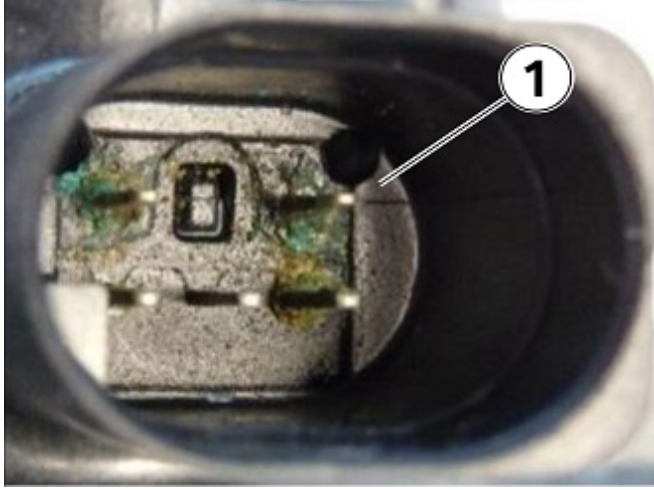
- Check for coolant contamination on the pins of the thermostat (1)

- Replace the thermostat following repair instruction **11 53 000 Remove and install/replace the coolant thermostat.**
- If there is corrosion on the pins the engine harness will need to be replaced along with the thermostat.
- Follow Repair Instruction **12 51 302 Remove and install/replace wiring harness section of sensor system module for cylinders 1-4.**
- If there is no corrosion on the pins the harness **will not** need replacement.

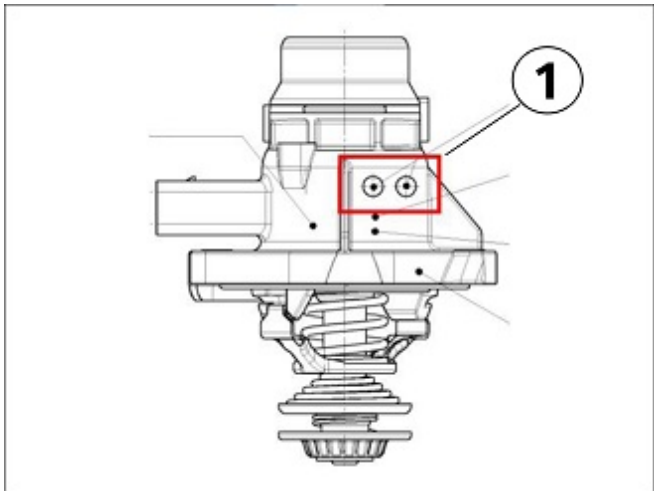
- The date code stamp is located on the side of the thermostat (1)

- Check the production date of the new part. Parts with a date code 12/31/2020 through 5/03/2021 should not be installed. **NOTE:** Parts within that production range should have been called back as part of a Parts Tech Return in 10/2021.

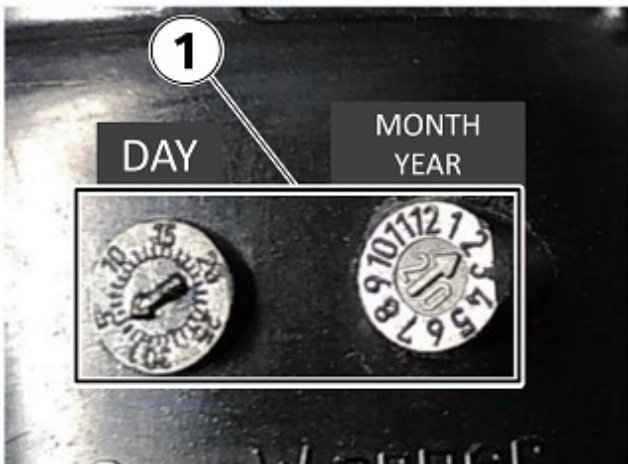
- Example of date code (1), showing the 5<sup>th</sup> of February 2020.
