MODEL

G12 (7 Series Sedan)	G30 M550i (5 Series)
----------------------	----------------------

SITUATION

This bulletin describes the procedures to inspect and if necessary replace the following components:

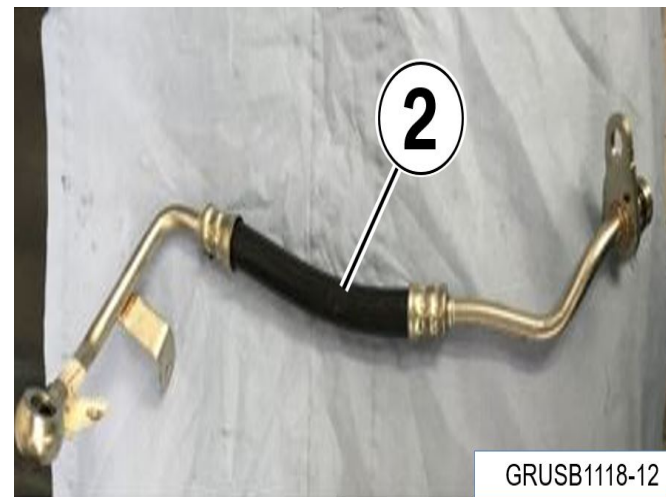
Stainless steel flexible section. This is the new design and should not be replaced.

(2) Black rubber flexible section. This line should be replaced.

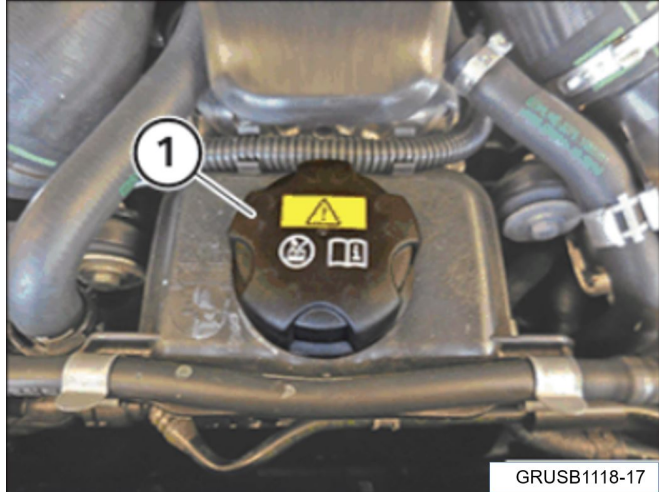
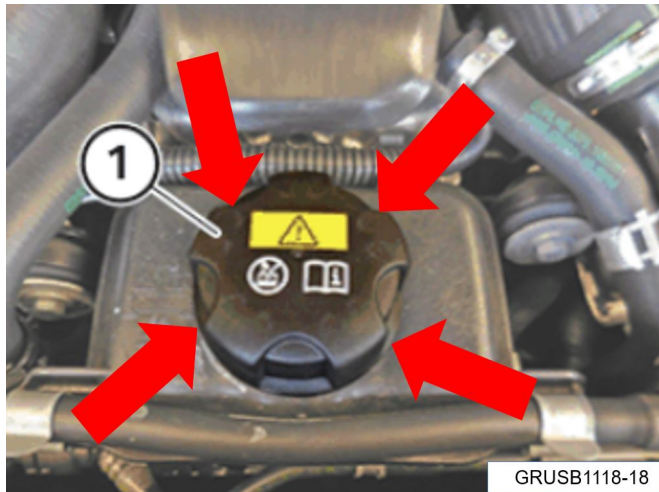
Locate and inspect the low temperature cooling system cap

(1) for traces of overflowing.

Do not remove the cap, if there are traces of wet or dried coolant around the cap surface then it is overflowing. If found overflowing, replace both charge air intercoolers. If not leaking, do not replace any parts and do not drain the cooling system.
