This Service Information bulletin replaces SI B11 15 16 dated August 2016

**MODEL**

F22 (2 Series Coupe)	F23 (2 Series Convertible)	F30 (3 Series Sedan)	F31 (3 Series Sports Wagon)
F32 (4 Series Coupe)	F33 (4 Series Convertible)	F34 (3 Series Gran Turismo)	F36 (4 Series Gran Coupe)
G12 (7 Series)	G30 (5 Series)	G32 (6 Series)

With the B58M engine, produced up to September 2017 only.

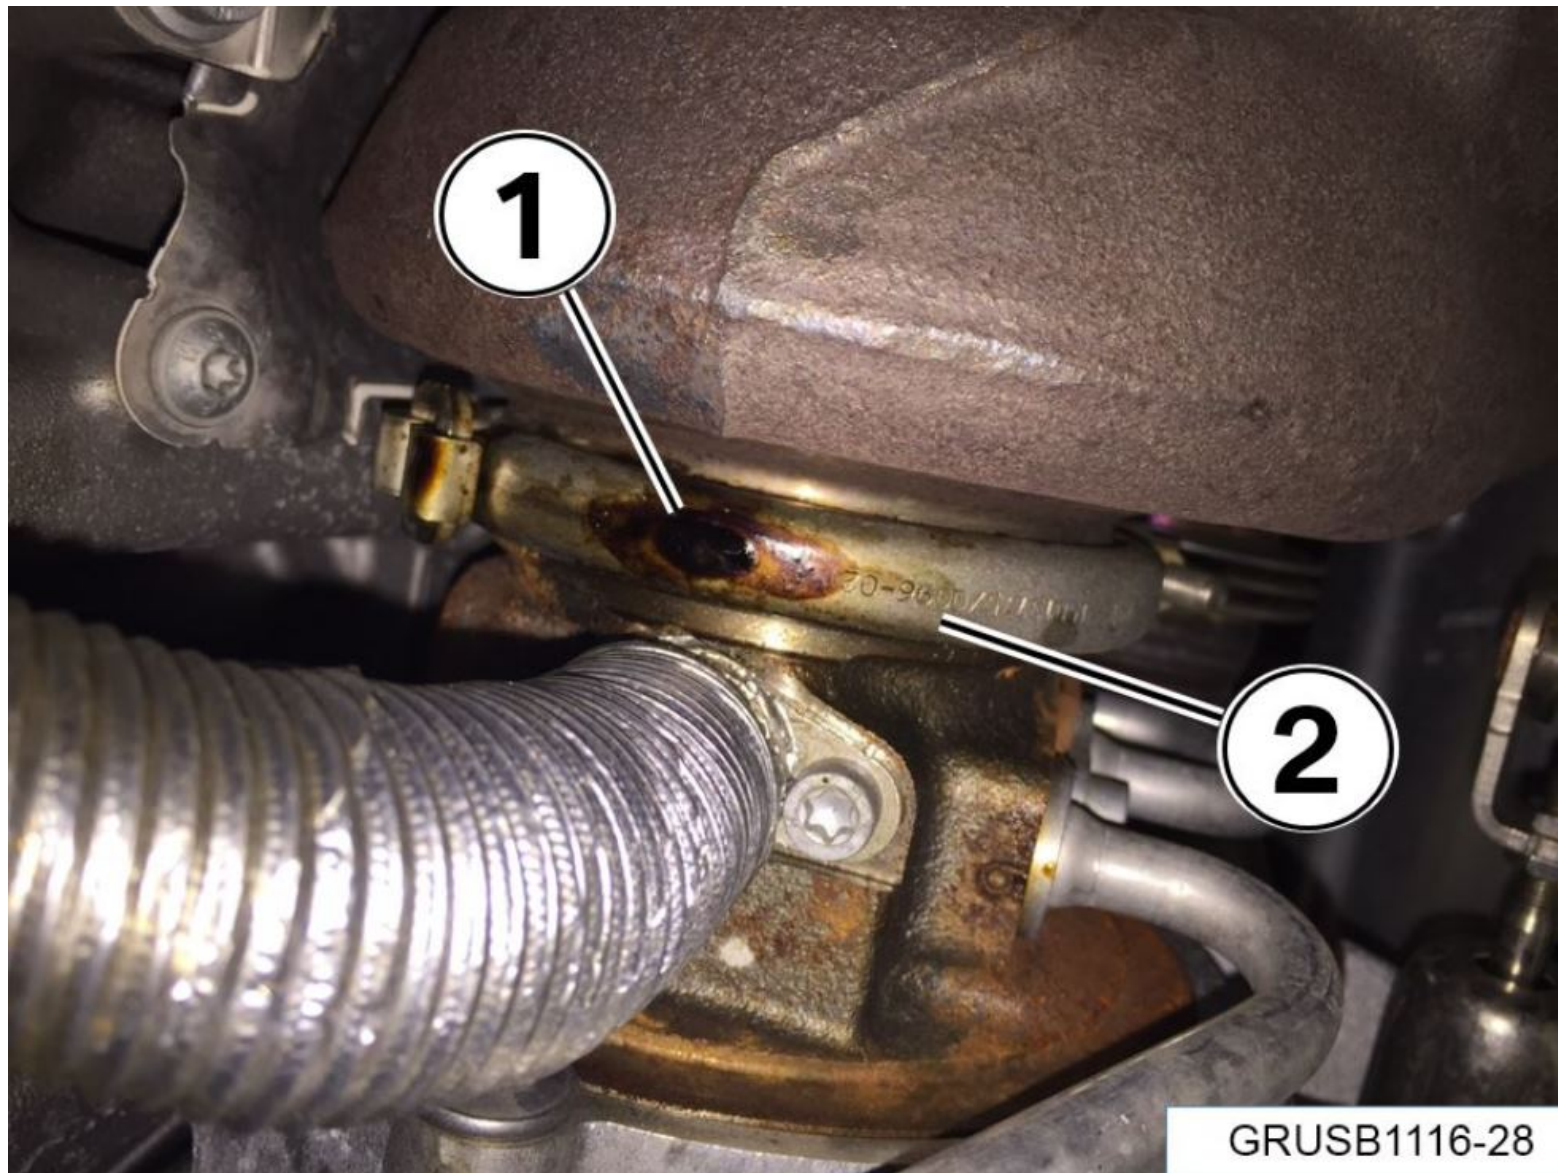
Engine oil (1) can be seen leaking from the bottom of the turbocharger near the band clamp (2).

The turbocharger band clamp is loose.

Tighten the turbocharger band clamp.
