## RECALL 20V-761: CHECK 48 V CABLE CONNECTIONS ON STARTER GENERATOR (SGR)

This Service Information Bulletin (Revision 2) replaces SI B12 01 21 **dated February 2021**.

## SITUATION

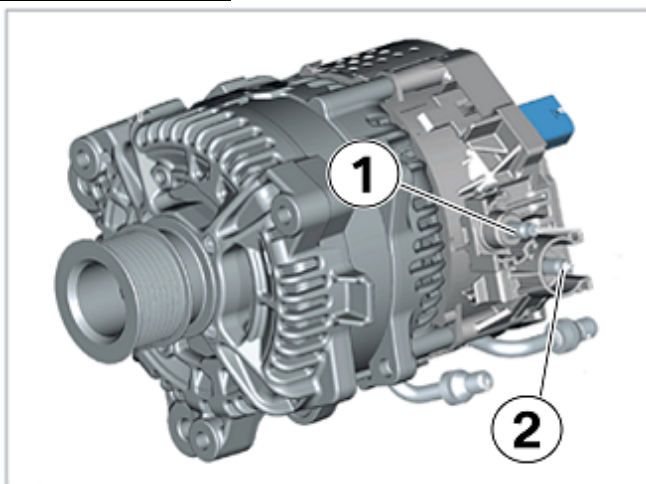
The 48-Volt battery cable connections to the starter / generator (SGR) may not have been assembled to specifications. Over time, this could lead to increased resistance at the connection(s) and, in rare cases, a thermal event.

Check the positive (1) and negative (2) cables for play at the mounting lugs on the SGR.

- Deactivate the 48 V electrical system (Repair instruction REP-TAT-P-6124-18-B47\_48V)
- Remove and discard the flange nut on the B+ or B- cable
- Install a new flange nut so that it's carefully started by hand to avoid cross-threading
- Torque to 19 Nm
