Vacuum Hose to Secondary Air Non-Return Valve

GROUP 12
Engine Electrical
Systems

B 12 04
98

MODEL: E46 - 323i/iA, 328i/iA produced 4/98 -7/98

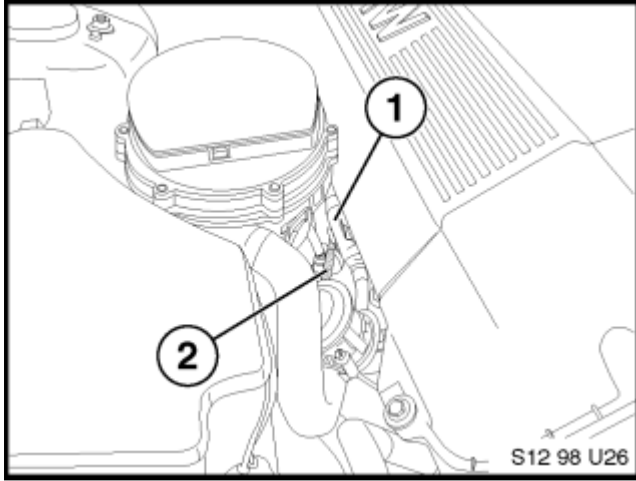
1. Check routing of the vacuum line (2) going to the non return valve. The vacuum line runs below the Oxygen Sensor wiring (1).

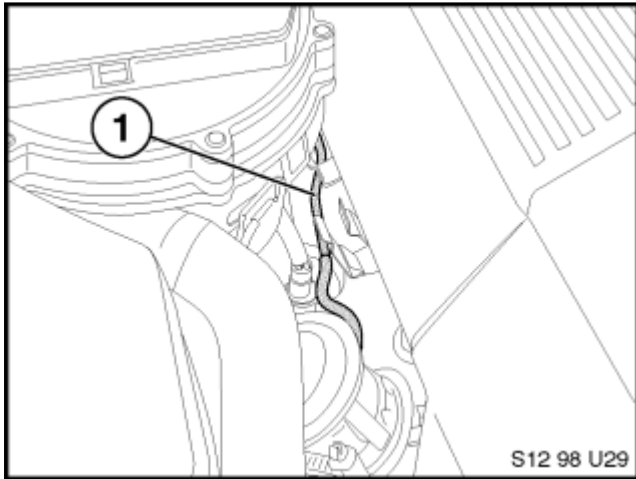
2. If the vacuum line (1) is too long it may come in contact with either the oxygen sensor or the exhaust manifold and become damaged.

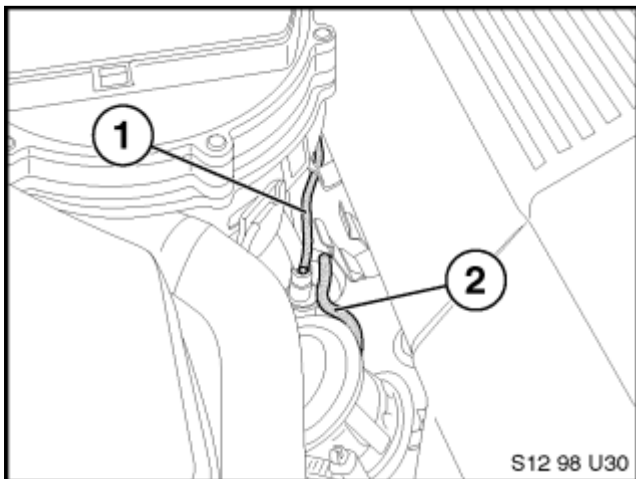
3. If the vacuum line is found to be damaged it may need to be replaced depending on the location of the damage.

Note: in the area of the front oxygen sensor the vacuum line changes from a plastic tube to a rubber hose.

a. If the damage is on the plastic tube (1):

- Cut off the damaged portion of the plastic tube

- Reinsert the plastic tube into the rubber hose if the hose is long enough. If the rubber hose is not long enough replace the hose and cut to the appropriate length to assure proper routing.

b. If the damage is on the rubber hose:

- Replace the rubber hose (2) and cut to the appropriate length to assure proper routing.
