RECALL 20V-465: CHECK STARTER BOLT

This Service Information bulletin (Revision 3) replaces SI B12 10 20 dated August 2020

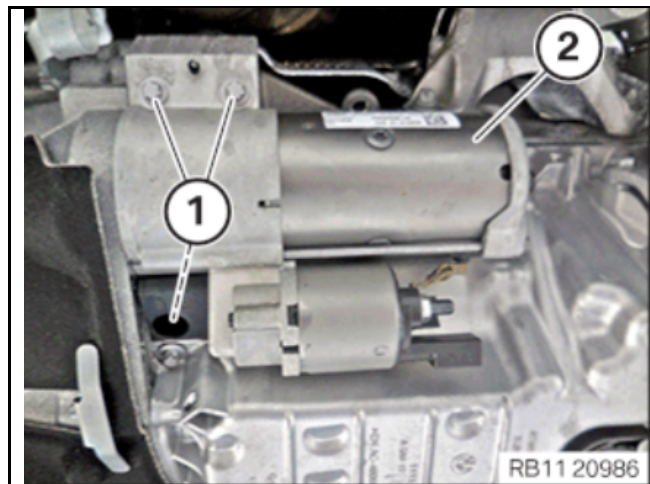
- Three starter bolts (1)
- Starter assembly (2)

2. Remove the starter as per repair Instruction 12 41 020 "Removing and installing or replacing the starter motor"

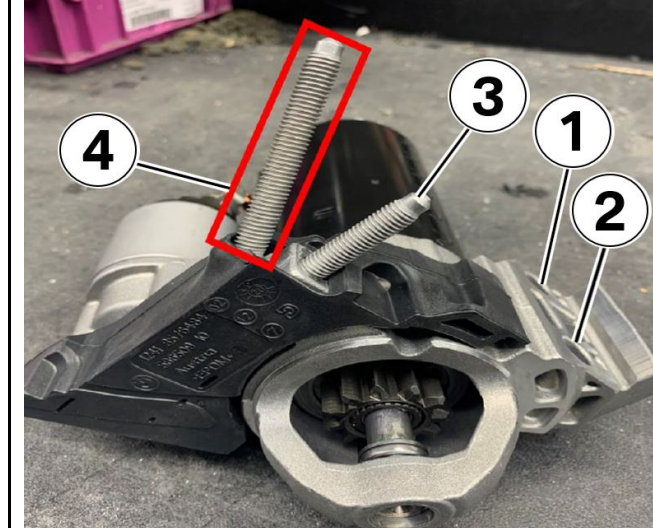
A bolt may have been incorrectly attached to the starter. The bolt could inadvertently fall into the transmission housing which could lead to damage and the possibility of stalling.

- Correct (1)
- Correct (2)
- Correct (3)
- Incorrect (4)

Remove the bolt in position 4 found in the picture.

If the black acoustic plug is damaged, then it must be replaced.
