RECALL 20V-761: CHECK 48 V CABLE CONNECTIONS TO THE STARTER GENERATOR (SGR)

This Service Information Bulletin (Revision 2) replaces SI B12 12 20 **dated December 2020**.

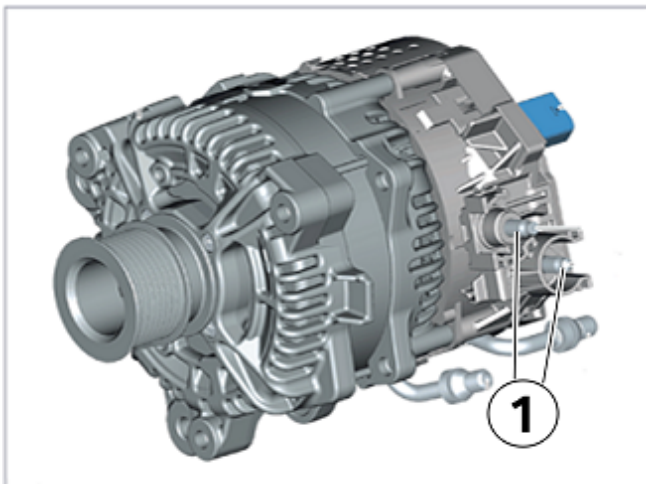
The 48-Volt battery cable connections to the starter / generator (SGR) may not have been assembled to specifications. Over time, this could lead to increased resistance at the connection(s) and, in rare cases, a thermal event.

Check the positive (1) and negative (2) cables for play at the mounting lugs on the SGR.

If the connections are tight and the cables cannot be moved by hand–

- No further action is necessary

If there is play in the connection to the SGR –

- Deactivate the 48 V electrical system (Repair instruction REP-TAT-P-6124-18-B47_48V)
- Remove and discard the flange nut on the B+ or B- cable.
- Install a new flange nut so that it's carefully started by hand to avoid cross-threading
- Torque to 19 Nm
