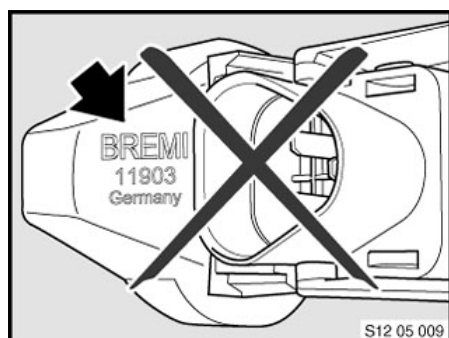
**Only coils manufactured by BREMI are affected.**

BREMI coils are easily recognized by the all **black, shiny housing**. Also, the brand name BREMI is molded on the rubber protective cover on top of the coil, under the connector plug.

On the affected vehicles, check the manufacturer of the ignition coils. If BREMI coils are found, replace them with Bosch ignition coils.

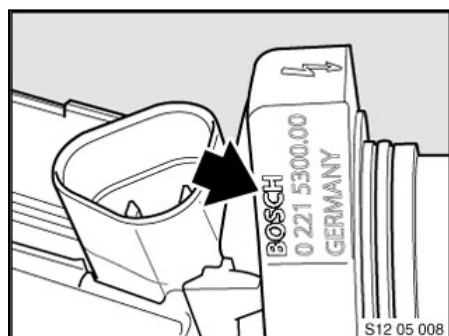
Bosch coils, which can also be fitted in the affected vehicles, are not affected and **should NOT** be replaced.

Bosch coils are easily recognized by the all **silver, aluminum housing**. Also, the brand name Bosch is molded on the rubber protective cover on top of the coil, under the connector plug.
