This Service Information bulletin supersedes SI B12 16 11 dated August 2011.

The customer complains the SES is illuminated and the engine has reduced power (engine failsafe mode). One of the following faults is stored in the DME memory:

FC 120308 boost pressure control, plausibility: pressure too low

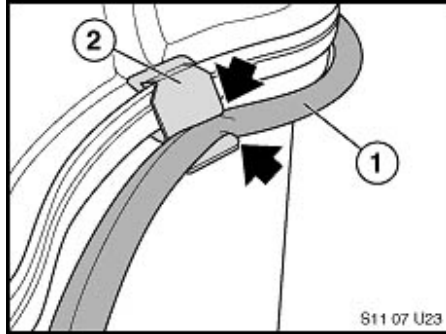
- Perform a quick inspection of all turbocharger boost control vacuum hoses; a slightly collapsed vacuum hose could lead to intermittent boost faults, or boost faults occurring only under heavy acceleration demands.

1. Restricted vacuum hose

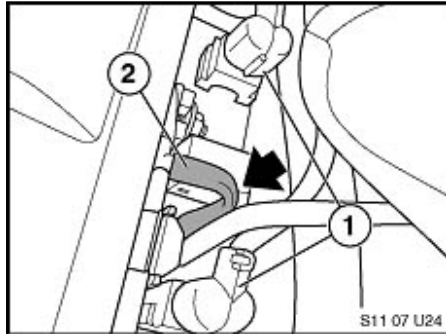
2. Retaining clip

1. Vacuum solenoid  
2. Kinked or restricted vacuum supply hose

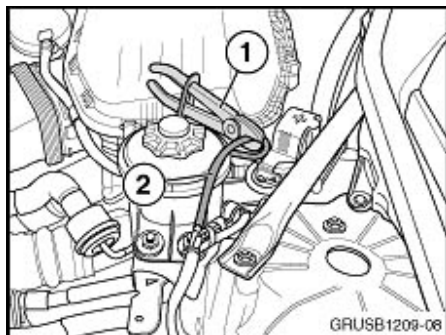
- Using a vacuum gauge can be very helpful in diagnosing a vehicle with intermittent boost faults. Although the problem may not be present long enough to set a boost fault, the gauge may show a hint of a deteriorating vacuum level that could ultimately lead to an effective repair. Connecting the vacuum gauge at the vacuum actuator with a “tee” connection will determine the integrity of the vacuum supply (compare values to the attachment). Erratic operation of the vacuum gauge is a hint that a control problem is present; comparing the gauge movement to another vehicle will help determine whether a problem is present.
- On models equipped with an exhaust flap, isolate or disconnect the vacuum supply to the exhaust flap to eliminate a leaking or a defective vacuum solenoid. This can be done very easily by blocking the hose located near the right front strut tower.

1. Suitable tool used to block the supply hose  
2. Vacuum supply hose for the exhaust flap solenoid
