MODEL

G30 (5 Series 540d xDrive)

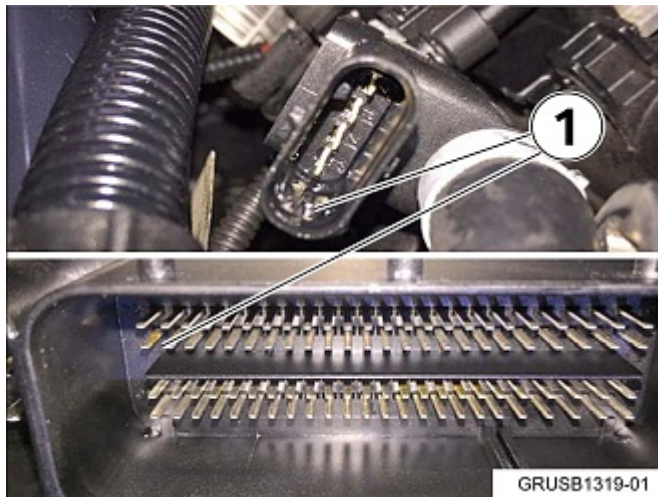
The fuel temperature/pressure sensor of the fuel supply line in the engine compartment is leaking at the connector

As a result, the fuel pre-supply pressure is often “detected” as being too low, even though it is actually within specifications.

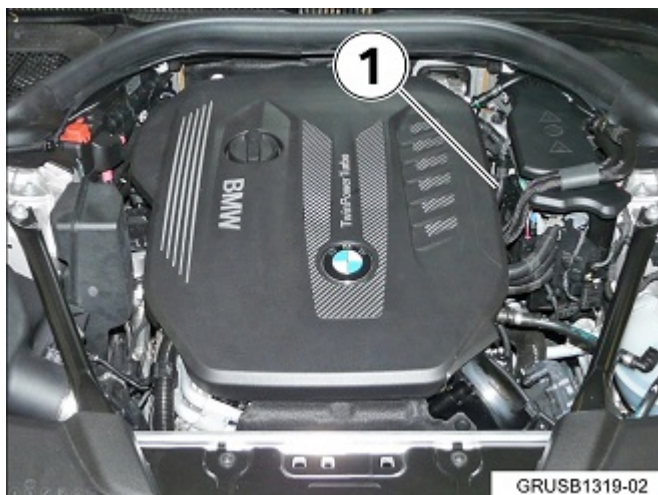
1. Check the electrical plug connections of the engine wiring harness at the DDE and the fuel temp/pressure sensor for fuel contamination.

Replace the fuel supply line in the engine compartment which contains the integrated fuel temperature/pressure sensor (PN 13 53 8 591 722).

Refer to Repair Instructions 13 53 330 “Replacing all leaked oil lines”.

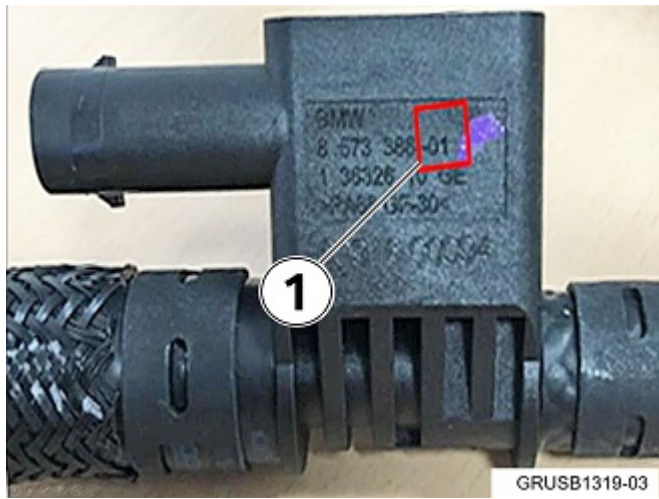
The improved fuel line can be determined by the change index (1) and part number located on the fuel temperature/pressure sensor of the fuel supply line.
