VOLUNTARY EMISSIONS RECALL: 20E-A02 - REPLACE HIGH PRESSURE PUMP

This Service Information Bulletin (Revision 1) replaces SI B13 03 20 **dated April 2020**.

G01 (X3 Sports Activity Vehicle)	G05 (X5 SAV)	G12 (7 Series Sedan)	G20 (3 Series Sedan)
G30 (5 Series Sedan)

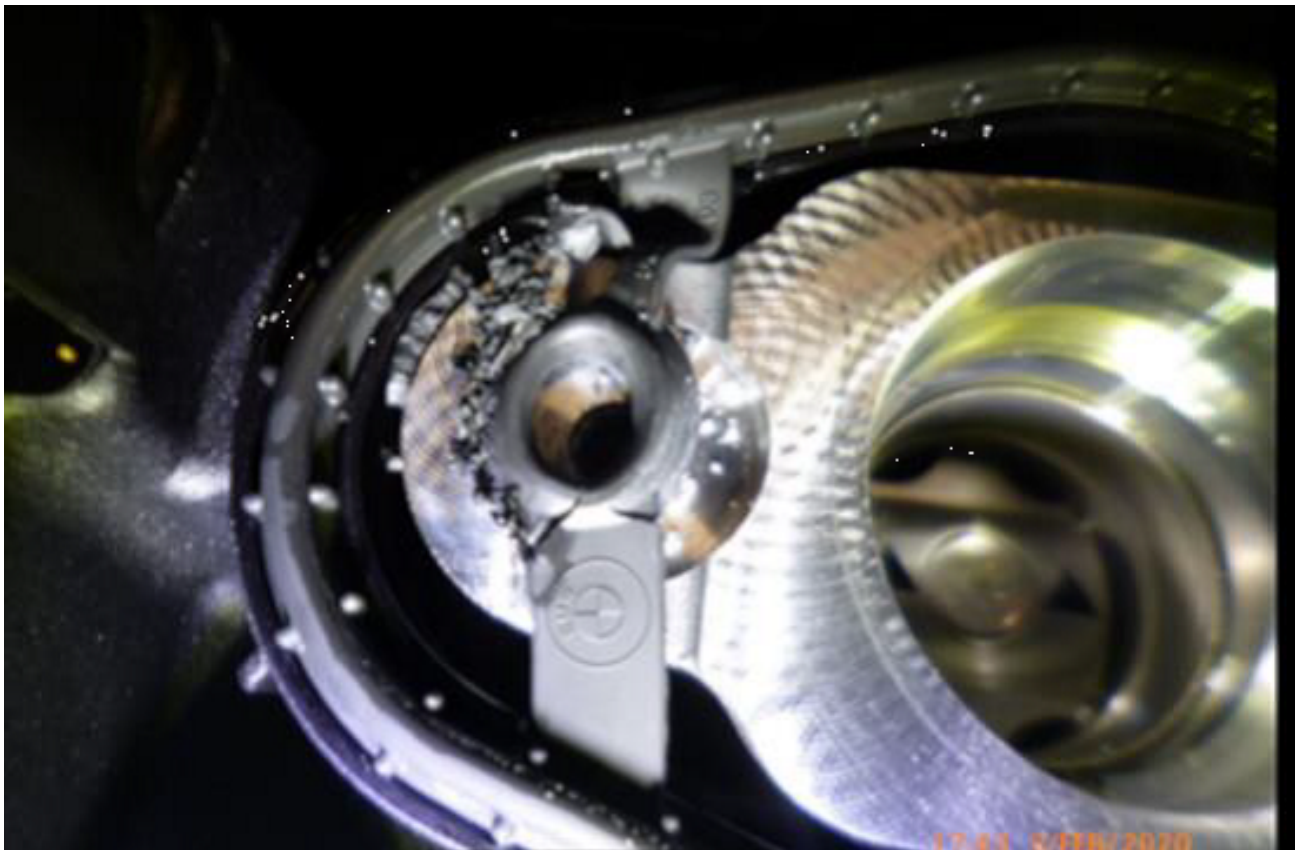
Due to an assembly error, the flange bolts for the high-pressure pump did not have the proper tightening torque applied.

1. Remove the high-pressure pump as per Repair Instruction 13 51 017 "Removing and installing high pressure pump".
2. For quality control purposes, capture a photo of the high-pressure pump gasket area as seen in the example below.

3. Email the photo with the VIN in the subject line to TAHDPDichtung@list.bmw.com. Do not wait for a response.

4. Install the new high-pressure pump as per Repair Instruction 13 51 017 "Removing and installing high pressure pump".
