TANK VENTILATION AND MIXTURE CONTROL FAULTS STORED IN THE DME

This Service Information Bulletin (Revision 01) replaces SI B13 04 20 **dated April 2020**.

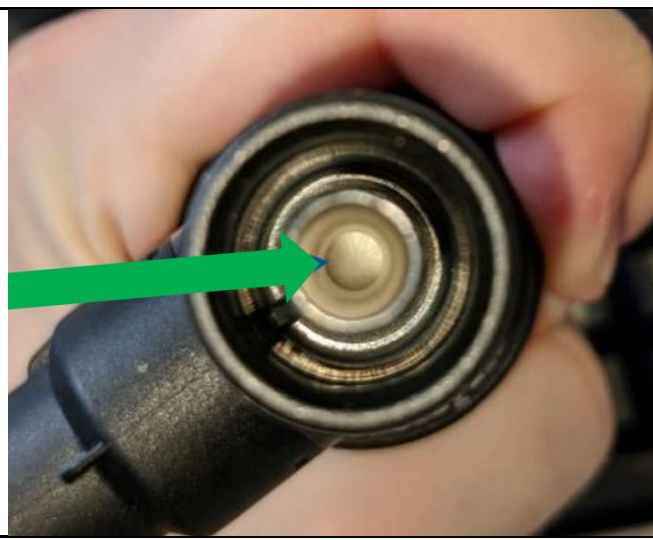
The reed valve dimple should be centered in the discharge port.

Note the **GREEN** arrow.

The reed valve in this photo is **good**.

Do not replace the valve.

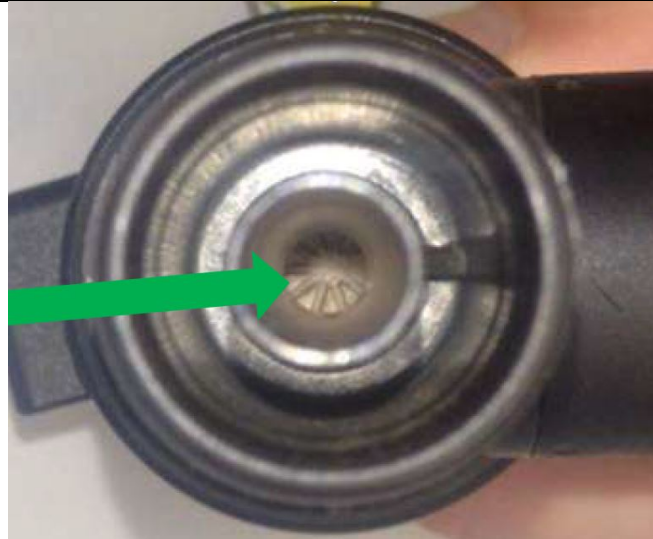
The reed valve center with vanes should be centered in the discharge port.

Note the **GREEN** arrow.

The reed valve in this photo is **good**.

Do not replace the valve.

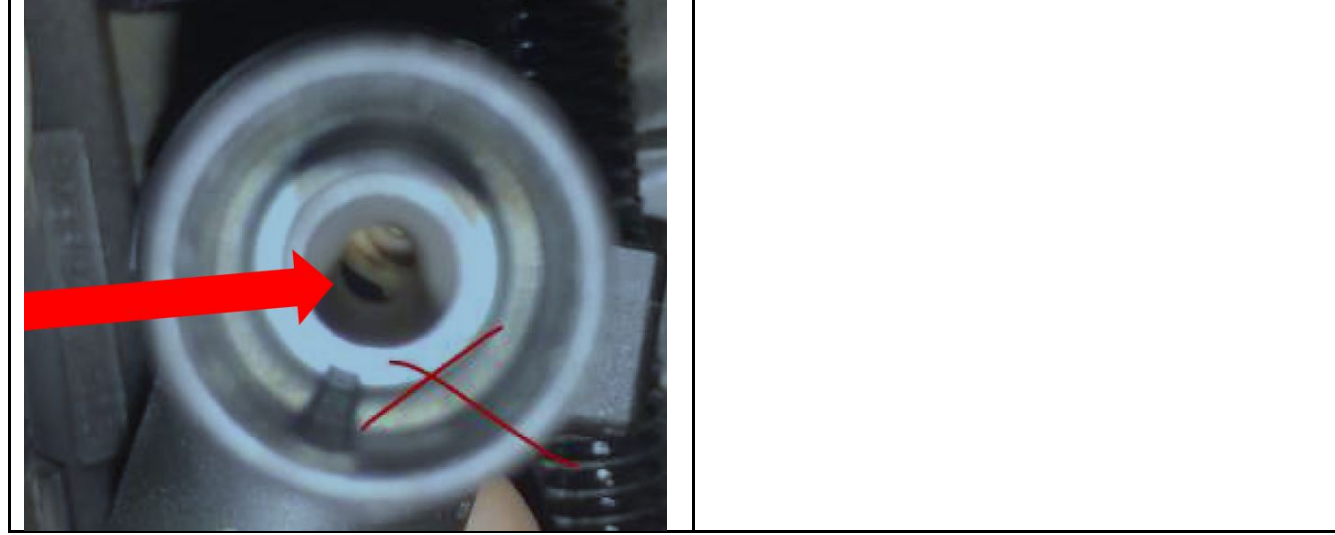
The edges of the reed valve can be ripped or torn apart.

It is very important to inspect the valve very closely using a borescope so that any damage is not overlooked.

Note the **RED** arrow.

The valve must be replaced.
