| E70 and E90 with the M57Y engine | | |

The Service Engine Soon lamp (MIL) is illuminated. Fault Code 46B7, Swirl Flap Actuator, is stored in the DDE.

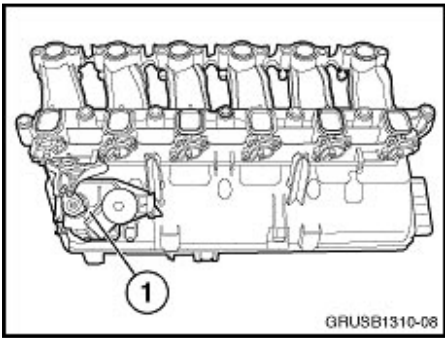
The linkage rod for the swirl flaps in the intake manifold is binding at the pivot point of the swirl flap actuator.

| | Remove the intake manifold (refer to Repair Instruction REP11 61 050). Turn the manifold over to access the swirl flap actuator (1). |
