## SITUATION

When diagnosing fuel tank evaporation system related faults on **vehicles equipped with DMTL systems**, **do not externally pressurize fuel tank** using Evaporative Leak Test Tool P/N 90 88 6 161 170 in conjunction with an ultrasound detector.

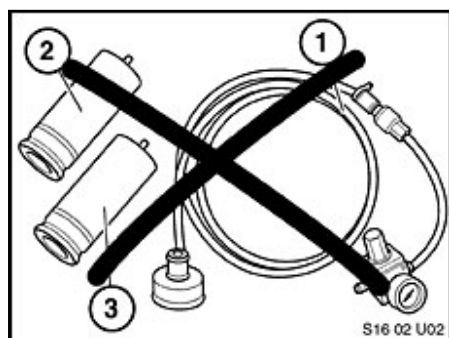
**Application of an external pressure to the fuel tank creates erroneous leaks from the DMTL check valve, which can be interpreted as a real evaporation system leakage.** Analysis of parts returned to Warranty revealed that the majority of replaced DMTL modules were actually not defective.

Evaporative Leak Test Tool PN 90 88 6 161 170 (indicated as # 1) **SHOULD NOT** be used to pressurize fuel tanks on the **DMTL** equipped vehicles.

Only appropriate DISplus/ GT1 test modules should be used to perform a fuel tank leak diagnosis (as described in RA 16 00 510).
