MODEL

G12 PHEV (740e xDrive)

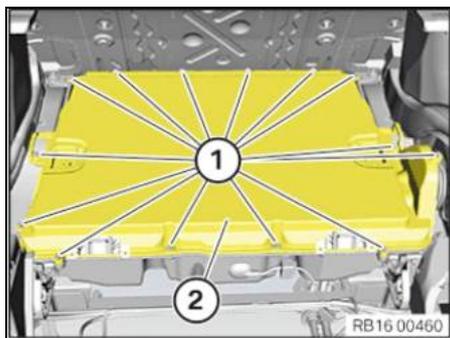
1. Verify the noise is coming from under the center of the luggage compartment.
2. Remove the luggage compartment trim panels (following the attached REP 16 11 030, "G12 PHEV Remove and install fuel tank") to access the fuel delivery module, on top of the fuel tank.

NOTE: The fuel tank does not have to be removed from the vehicle's luggage compartment

to perform this repair procedure.

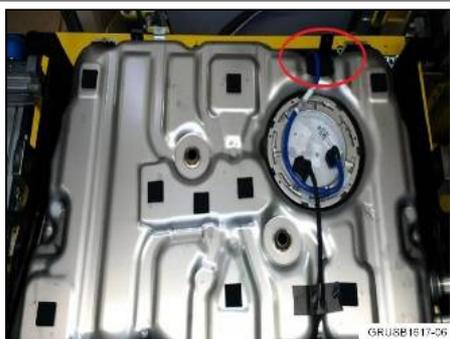
3. Remove the housing cover of the fuel tank. Loosen the screws (1) and remove the housing cover by lifting up.

Installation Note: Screws may be reused.

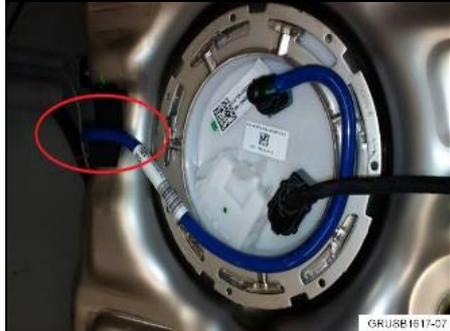
Fuel line is vibrating and coming into contact with the fuel tank.

4. Locate fuel line at the front of the tank that is rattling.

5. Install a damping strip (part number 16 11 7 297 317) on tank underneath fuel line.
