SERVICE ACTION: ADD SILICONE BOOSTER TO LOW TEMP COOLING SYSTEM

This Service Information Bulletin (Revision 2) replaces SI B17 01 20 **dated February 2020**.

G05 (X5 Sports Activity Vehicle)	G06 (X6 Sports Activity Coupe)	G07 (X7 Sports Activity Vehicle)	All with the N63B or N63M engine
----------------------------------	--------------------------------	----------------------------------	----------------------------------

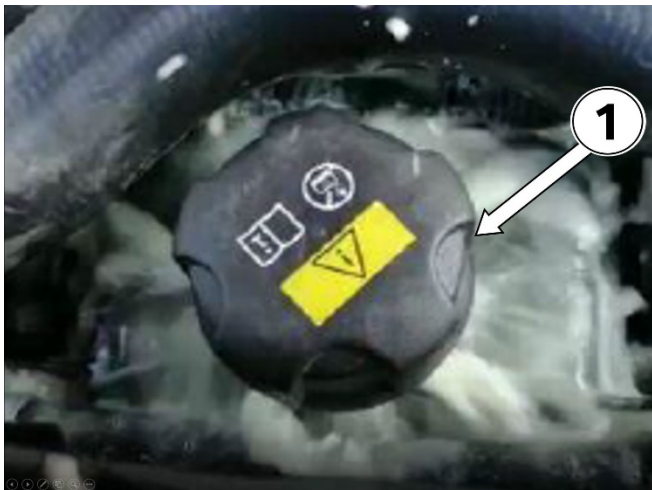
Step One: Remove the reservoir cap for the low temp cooling system. Examples of excessive pressure release are in the videos below.

Was pressure released (1)?

- Yes: Continue to Step Two.
- No: Continue to Step Three.

Step Two: Do not add the silicon booster if there is significant pressure released from the low temp cooling system. Follow [SI B17 06 17](#) to properly repair the vehicle.

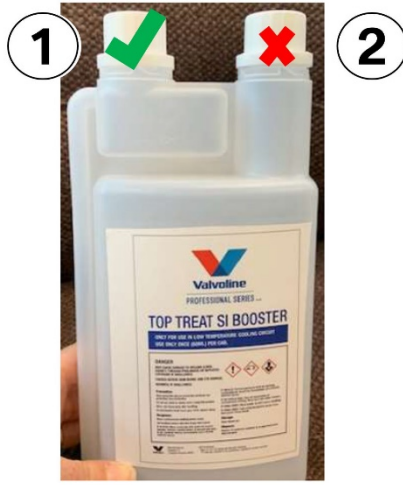
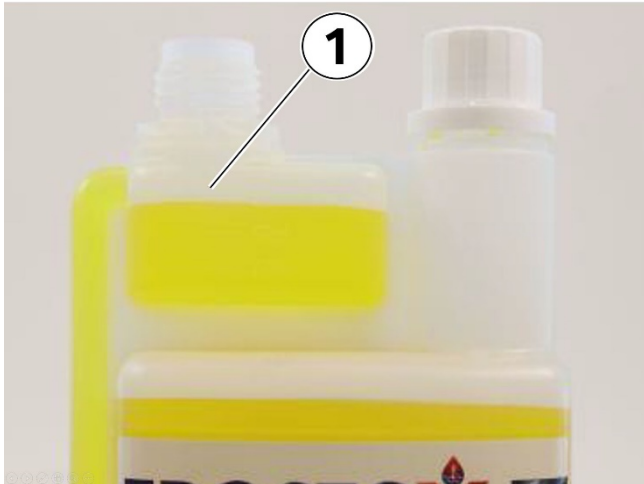
Remove the cap for the small reservoir (1).
Do not remove the cap for direct fill (2).

Step Three: Adding the silicon booster additive. Read the safety information label on the booster bottle for proper handling, storage and disposal of the additive

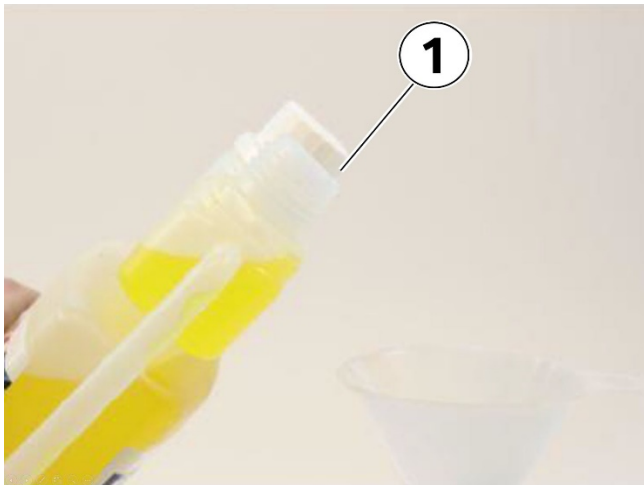
Squeeze the bottle until the reservoir fills to 60 ml (1).

Pour the 60 ml of concentrate into the low temp coolant reservoir. **Do not spill** any of the concentrate.

- Use a funnel to help in filling the low temp reservoir.
- Tightly close the cap to the additive bottle right after use.
