CHECK CONTROL MESSAGE TOP UP COOLANT (I12)

This Service Information bulletin replaces SI B17 03 18 dated **June 2018**

I12 (i8)	I15 (i8 Roadster)
----------	-------------------

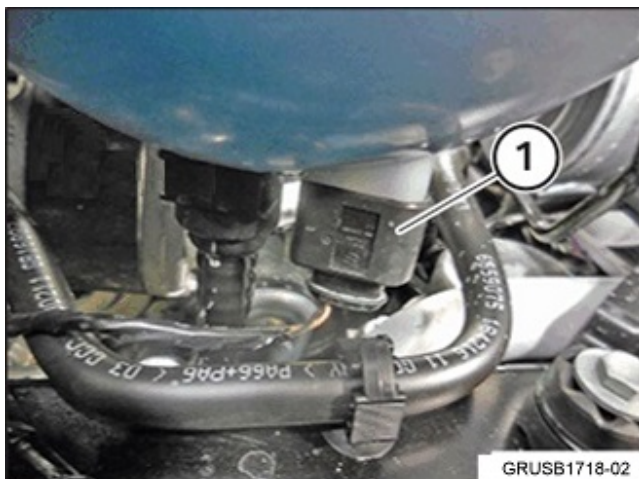
1. BDC software error
2. Poor contact in the electrical connector at the coolant level sensor in the expansion tank

Replace the expansion tank and plug connection (1):
