SERVICE ACTION: REPLACE THE MOUNT FOR THE TRANSMISSION OIL COOLER THERMOSTAT

G12 (7 Series)	G30 (5 Series)		
----------------	----------------	--	--

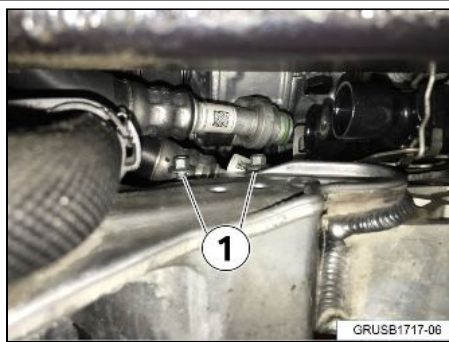
Note: The illustration shows the cooler lines removed for clarity and the bolts already loosened as a reference for the location of the bolts. **Do not remove the transmission cooler lines.**

- Remove the two 8mm bolts (1) that hold the thermostat bracket to the sub-frame. Replace the bolts (PN 34 30 6 771 214) during installation and tighten to 8 Nm.
