This Service Information Bulletin (Revision 6) replaces SI B17 06 17 **dated March 2020**.

G05 (X5 Sports Activity Vehicle)	G07 (X7 Sports Activity Vehicle)	G06 (X6 Sports Activity Coupe)	G12 (7 Series Sedan)
G30 (5 Series Sedan)

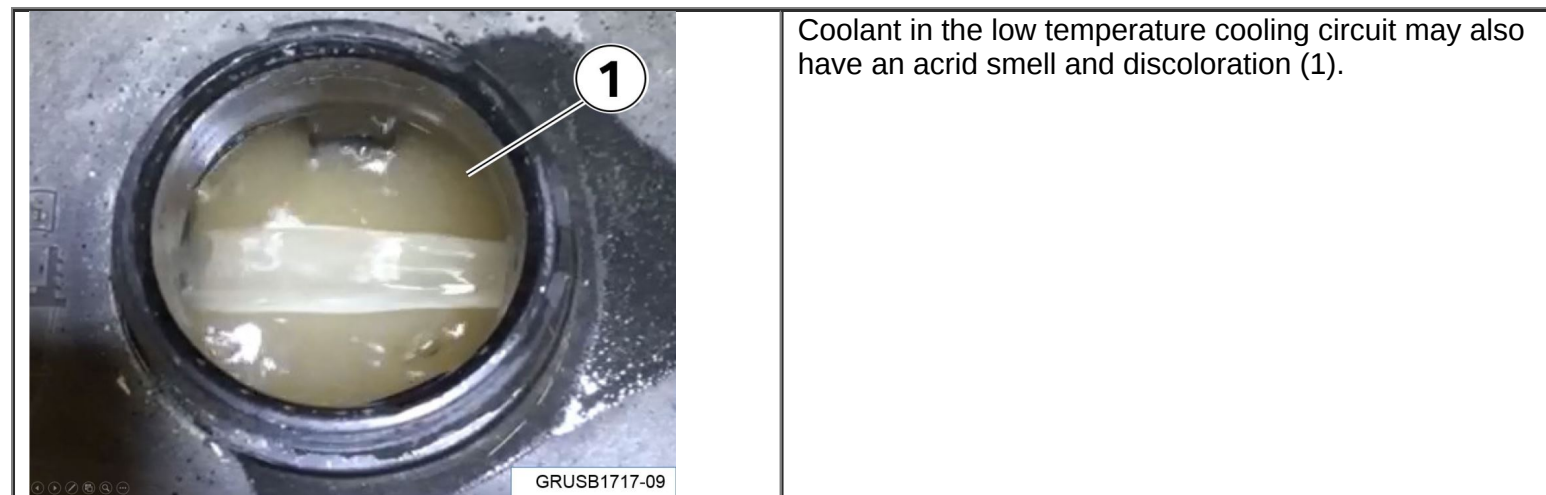
Coolant leaking from the engine compartment. Traces of coolant leaking from the expansion tank of the low temperature cooling system.

Coolant in the low temperature cooling circuit may also have an acrid smell and discoloration (1).

Aluminum corrosion in the charge air intercoolers, or in the radiator for the low temperature cooling is causing an unfavorable chemical reaction to the coolant.

Replace the radiator and both charge air coolers for the low temperature cooling circuit. Allow all the coolant in the system to drain during repairs (do not clamp off hoses).
