**DELIVERY STOP: INSPECT NUTS ON CATALYTIC CONVERTER**

This Service Information Bulletin (Revision 2) replaces SI B18 02 20 **dated June 2020**.

**MODEL**

with B58 engine

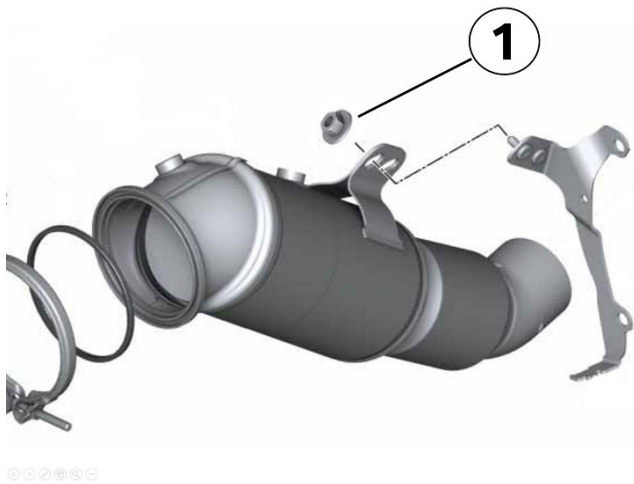
The nuts holding the catalytic converter to a bracket in the engine compartment may become loose. Over time, this may lead to damage to the exhaust system.

The nuts on the catalytic converter bracket in the engine compartment have been incorrectly torqued (19 Nm instead of 28 Nm).

Check which type of nuts (1) are present on the holder of the catalytic converter and, if necessary, tighten the nuts to proper specification.

Tighten the existing copper nuts to 28 Nm.
