MODEL

112 (i8)

Squeaking noises coming from the rear area may be heard in the vehicle interior when driving over rough or uneven road surfaces

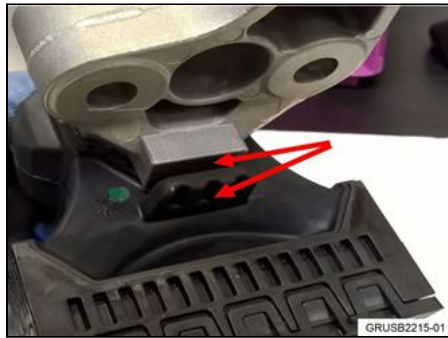
Friction between the engine mount and its contact surface with the rear axle.

Grease contact point between the engine mount and the rear axle.
