This Service Information bulletin supersedes SI B24 01 08 **dated May 2010.**

| E60, E61 with N52K or N54 and ZF 6HP19TU (6HP21) or 6HP19X TU from SOP up to 02/08 | E65, E66 with N62TU or N73 and ZF 6HP26, produced from 03/05 up to 10/06 | E70 (X5) with N52K and ZF 6HP19X TU (6HP21X) produced from SOP up to 02/08 | E90, E91, E92, E93 with N52K or N54 and ZF 6HP19TU (6HP21) or 6HP19X TU from SOP up to 02/08 |

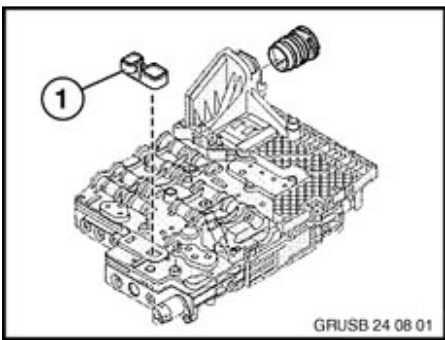
- a. Low transmission fluid level; or
- b. Internal transmission pressure leak caused by a defective adapter seal (rectangular) between the transmission housing and the Mechatronic.

4. If the Mechatronic adapter seal (rectangular) (1) is found to be defective (cracks, seal damage, etc.), replace it with the new part.
5. Reinstall the Mechatronic and an oil pan, using a new oil pan gasket, a new Mechatronic sealing sleeve (round), and a new drain plug. **The oil pan should NOT be replaced.**
6. Fill and adjust the transmission fluid, using the previously saved Shell M-1375.4 (P/N 83 22 0 142 516). For the filling procedure, refer to REP 00 11 500

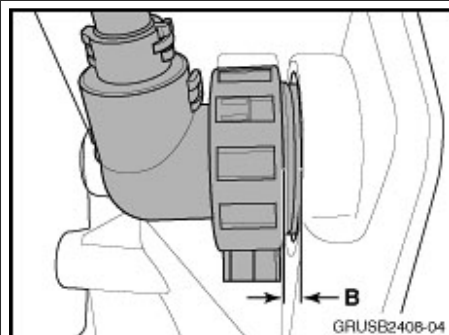
After installation, the correct distance between the transmission harness connector and the housing surface (B) should not exceed 3 mm. In case the sealing sleeve is not inserted correctly, an intermittent connection problem between the Mechatronic and the vehicle harness connector will occur, resulting in various EGS communication faults (e.g., FC 5079 “Serial wire message missing”; FC 507A “Serial line signal plausibility”); “Gearbox Emergency Program” light illumination; and the transmission entering failsafe mode.
