This Service Information bulletin supersedes S.I. B24 03 03 **dated June 2003**.

| E39 525iA, 530iA with 5HP19 produced 04/02 11/02 | <b>UPDATE !</b> E46 325iTA, 325CiA, 325CicA, 330iA, 330CiA, 330CicA with M54 and 5HP19 produced 04/02 02/03 | <b>UPDATE !</b> E46 325iA with M56 (SULEV) produced up to 04/03 | E85 Z4 2.5, Z4 3.0 with 5HP19 produced up to 11/02 |

Customer may complain of a harsh 3-2 and 2-1 downshifts (with "clunk" noise) when coming to a stop.

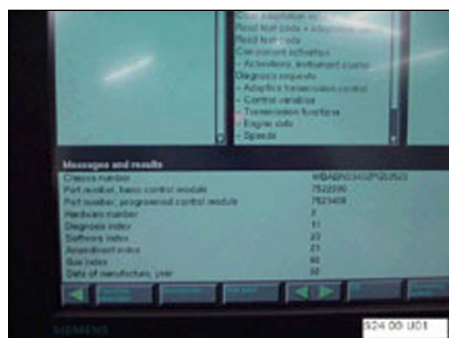
Incorrect programming dataset in EGS control module.

The incorrect dataset can be recognized by the "Amendment index" lower then 23, as displayed on the EGS module diagnostic identification page.

Amendment index lower then 23, indicates incorrect EGS dataset.

**On a customer complaint basis only**, reprogram EGS control module using the updated software.
