SIB 24 04 16

G12 N63R - Ticking Noises From Transmission Cooler Lines Area

G12 (750i/750ix)

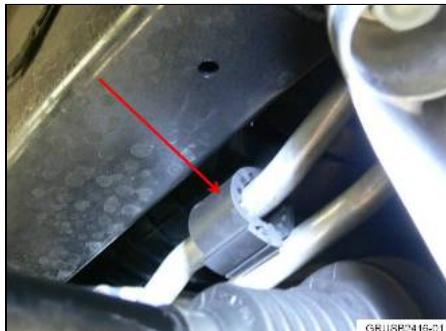
Customer reports an audible clicking noise in the driver's footwell area, heard directly after the transmission shifts.

Interference between the transmission cooling lines and engine support mounts.

1. Remove front, left wheel.
2. Remove the left front wheel arch cover according to Repair Instruction REP 5171 038.
3. Install the rubber protection ring (PN 64 53 7 578 706) on the return transmission cooler line, where shown in the illustration.

Note: Applying a small amount of water on the rubber protection ring, helps to place it at the correct position on the cooler line.
