## MODEL

E60, E61 with 6HP19TU, 6HP26TU transmissions and option code 2STBA

E63, E64 with 6HP26TU transmission and option code 2STBA

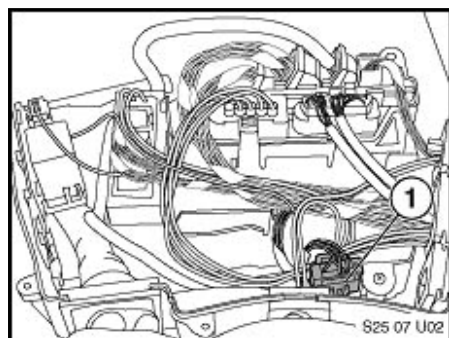
Upshift and downshift requests from both paddle shifters are transferred directly to the EGS transmission control module via a single wire connection: from the paddle shifters via SZL connector X1880, then engine connector X6031 up to the transmission control module (via Mechatronic connector X8500).

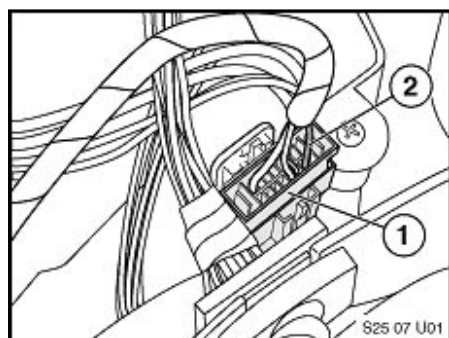
The most convenient location to monitor the paddle shifter signals is the connector X6031 (12-pin black), located inside the E-box on the front wall next to the ground harness (1).

1. Remove the left lower side of the microfilter housing (refer to RA64 31 061).
2. Remove the E-box cover and locate the 12-pin connector X6031 (1).
3. In the connector X6031, locate the blue/grey (2) wire (pin #11) paddle shifter signal from the SZL.

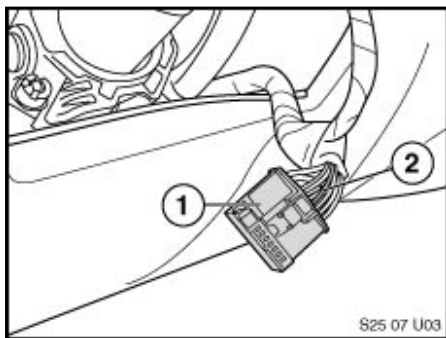
6. Continue monitoring the voltage at pin #11 of the connector X6031 when operating the steering wheel paddle shifters with the engine running and the transmission in position D.

7. The correct voltage values should be the following:

- "D" position between 3.7 V - 3.8 V
- "Upshift" between 2.4 V - 2.5 V
- "Downshift" between 1.2 V - 1.25 V

8. If incorrect values (or no voltage changes) are present when the paddles are operated, then continue troubleshooting the signal wire between the connector X6031 pin #11 and the SZL (Steering Column Switch Center) 16-pin connector X1880, pin #13. Look for the backed-up pins or lost continuity in the signal wire.
