MODEL

G30 530i

With the B46O engine and rear wheel drive (not xDrive vehicles)

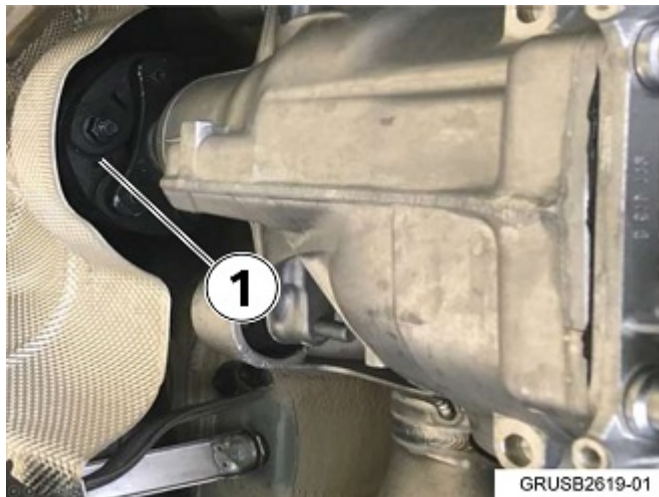
Raise the vehicle to inspect the flex disc at the rear differential (1).

Check the location of the rubber burr on the body of the flexible disc.

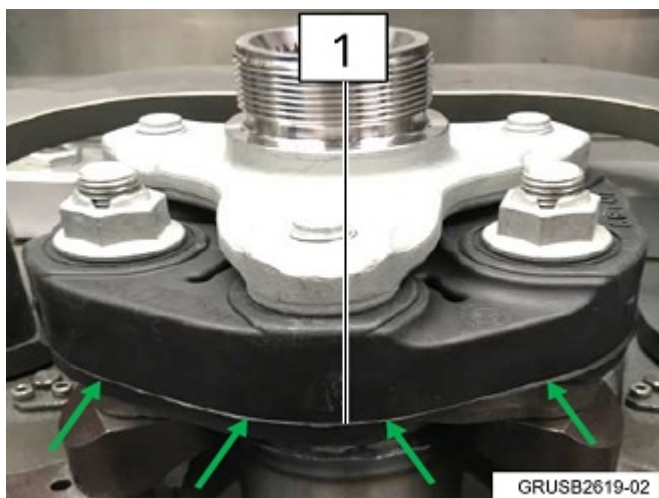
A properly installed flex disc will have the burr closer to the front of the vehicle (1).

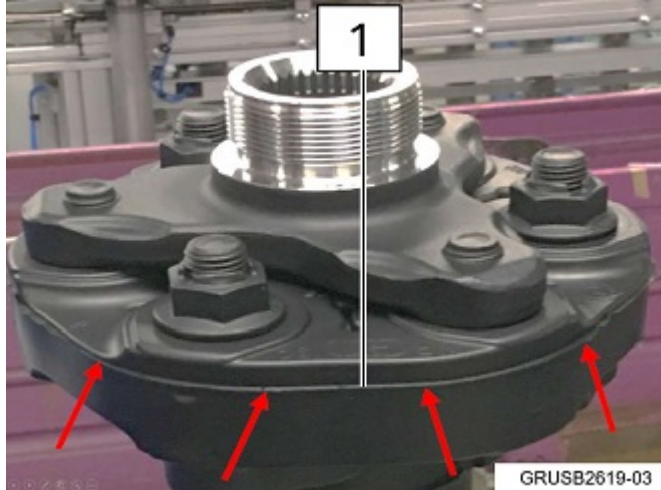
Imbalance in the rear driveshaft flex disc (giubo).

A flex disc installed incorrectly will have the burr closer to the rear differential (1).

If the replace the rear driveshaft if the flex disc is installed incorrectly following Repair Instruction 26 11 000 - Completely remove and install the propeller shaft.

NOTE: The driveshaft and rear flex disc are balanced as a complete unit (rear flex disc can't be replaced as a separate part).
