Service Action: Retorque Stiffening Plate Bolts on Front and Rear Axle

112 (i8)

On the front and rear axle stiffening plate bolts, the intended tightening torque may not have been reached during assembly.

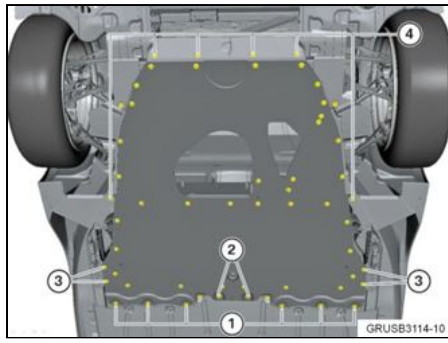
All bolts in the illustration numbered 1, 2, 3, and 4 are NOT to be retorqued!

Retorque all bolts M8x21 (Torx T50).

Loosen them one by one (approx. 45 degrees) and retorque one by one to 28 Nm.

Note: Loosen and retorque each screw before starting the next one.
