SERVICE ACTION: CHECK, AND IF REQUIRED, REPLACE THE RIGHTFRONT HALF SHAFT

G01 (X3)			
----------	--	--	--

This Service Action involves G01 (X3) produced from August 31, 2017 to September 6, 2017.

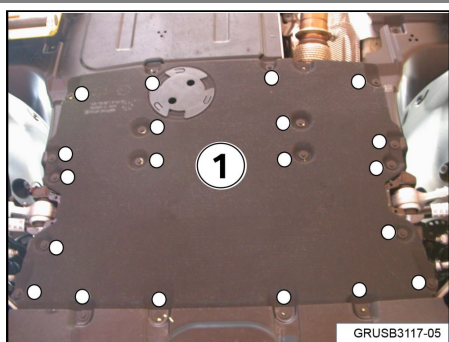
Remove the center lower protection cover (1).
Tightening torque of screws when reinstalling is 3Nm.

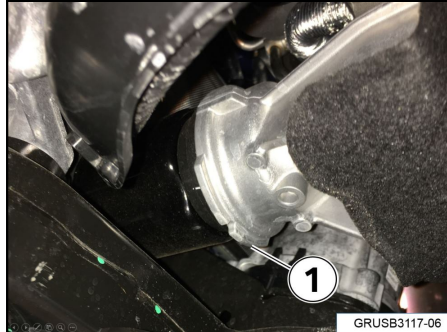
An oil leak may develop at the right front axle output shaft where the shaft enters the output shaft extension housing.

Manufacturing defect of the circlip that holds the output shaft into the extension housing.

Check the right side output shaft where it enters the extension housing (1) for an oil leak. If oil is leaking, replace the output shaft. Follow Repair Instruction **31 60 000 Removing and installing/replacing left or right output shaft**.

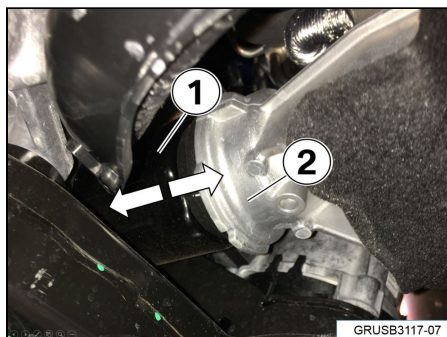
If there is no oil leak: Check for play in the output shaft (by hand) and pull the half shaft (1) as far as possible away from the extension housing (2).

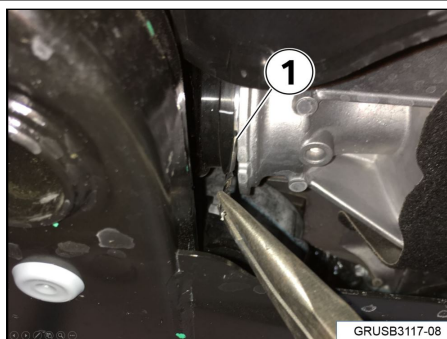
Insert a 3mm feeler gauge (3mm drill bit shown) into the gap between the output shaft and the extension housing (1). If the feeler gauge fits tight or will not fit (gap is $\leq 3\text{mm}$) then no further repair is necessary. If the feeler gauge fits loose (gap $>3\text{mm}$), replace the output shaft. Follow Repair Instruction **31 60 000 Removing and installing/replacing left or right output shaft. (Right Side - KSD2: 31 60 504)**

Check the gap of the **right side half shaft** where it enters the extension housing. If the gap is larger than 3mm, **replace the half shaft**.
