Front Suspension Ride Height Has Fallen

This Service Information Bulletin (Revision 1) replaces SI B31 05 14 **dated October 2014**.

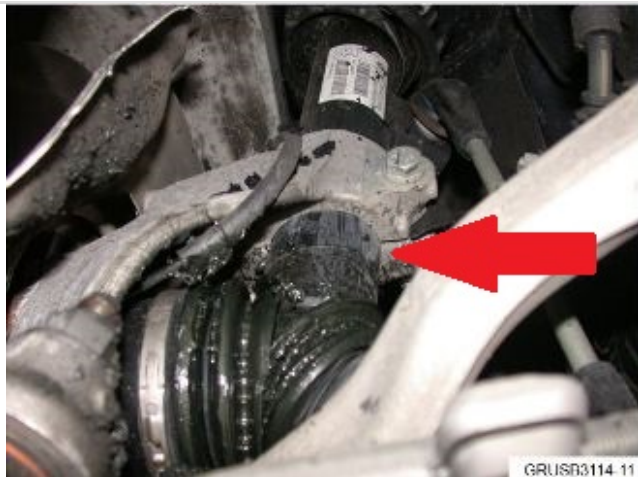
The front suspension ride height has dropped on one or both sides due to overload.

This is caused by driving over obstacles (e.g. potholes), or an impact severe enough for the front spring strut damper to slip through the clamp of the steering knuckle.

The slippage of the dampers from overload is intentional, as it protects the body from severe damage by dissipating kinetic energy through the clamp.

Replacement of steering knuckle and spring strut damper are required, along with any further damaged components (e.g., tires, axles, xDrive) and related required hardware.
