Models

I12 (i8)

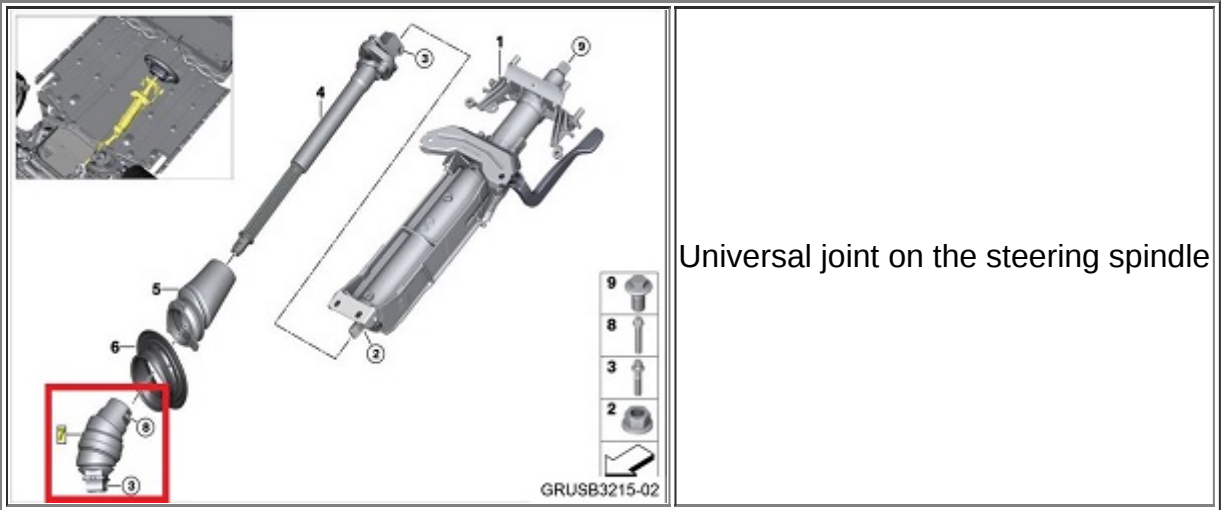
There are crackling noises from the area around the steering column when steering into bends or maneuvering the vehicle.

CAUSE

Replace the universal joint per Repair Manual RA 32 31 215, "Removing and installing/replacing double pivot (universal joint) for steering shaft, bottom."
