Model

I12 (i8 Coupe)

I15 (i8 Roadster)

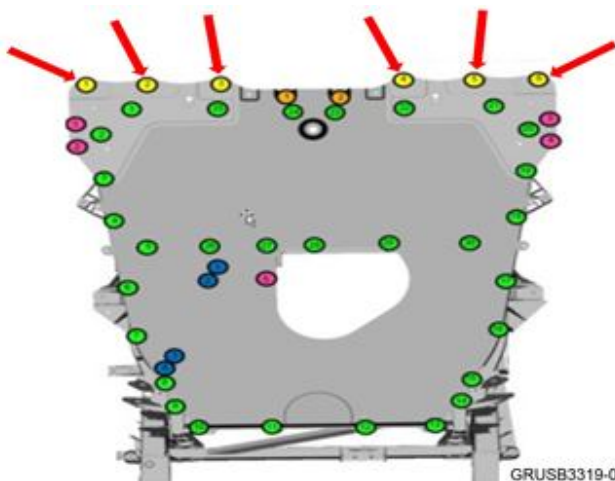
The drivability/steering behavior appears inconsistent.

Rear axle stiffening plate.

3. With the vehicle on an alignment rack so that the vehicle is resting on all four (4) wheels, retighten the 30 M8 bolts (shown in green) for the stiffening plate on the rear axle module.

- Loosen each bolt (shown in green) by approx. 45 degrees, then retighten with 28 Nm
- Do not proceed to the next bolt until the previous one has been torqued

Note: The 30 M8 ISA bolts **DO NOT HAVE WASHERS.**

- Do not replace the M8 bolts

4. Replace the 6 M10 Torx bolts as shown (red arrows) and tighten them with 56 Nm + 90°.

- Replace and tighten one bolt at a time
