This Service Information bulletin replaces SI B33 03 15 **dated October 2015**

F85 – X5M

F86 – X6M

There is an oil leak from the rear differential housing.

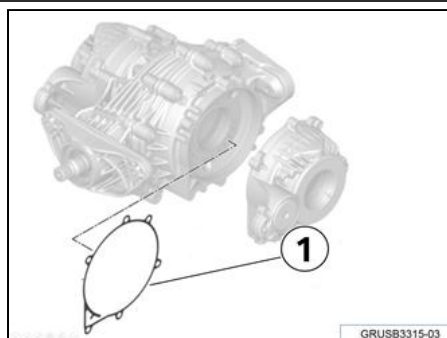
Gaskets are available through EPC (PN 33 10 7 601 264) for resealing the superimposing gear cases to the main differential housing (1)

Replace the gaskets between the superimposing gear cases and the main differential housing.

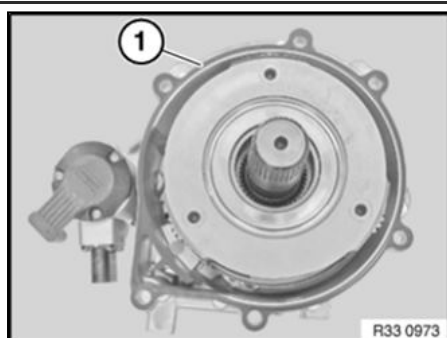
Both halves of the QMVH (1) will need to be resealed during the repair (do not repair only the side that is leaking).

Refer to the Repair Instruction **33 11 694 Overview of rear axle final drive (Dynamic Performance Control)** for complete resealing instructions.
