SERVICE ACTION: CHECKING THE THRUST WASHER AND THE REAR AXLE ANTI-ROLL BAR

F90 (M5 Sedan)	F91 (M8 Convertible)	F92 (M8 Coupe)	G14 (8 Series Convertible)
G15 (8 Series Coupe)	G16 (8 Series Gran Coupe)

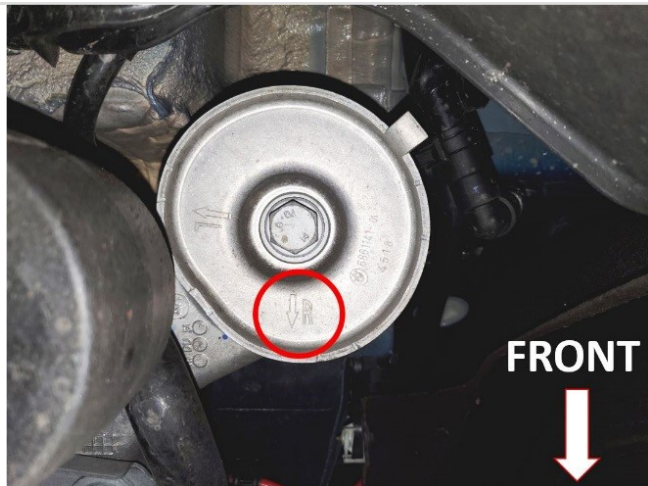
On vehicles with an incorrect setting of the thrust washer, contact between the thrust washer and the sway bar may occur over time. This can lead to corrosion and breakage of the anti-roll bar.

Installation error of the **right** side rear axle thrust washer during manufacturing.

Image shows the rear axle thrust washer on the right side.

Correct positioning:
Arrow R (circled) in the direction of travel

No: Remove and replace the thrust washer bolt. Correctly position the thrust washer on the rubber mount of the rear axle support.

- Tighten the new bolt to 185 Nm

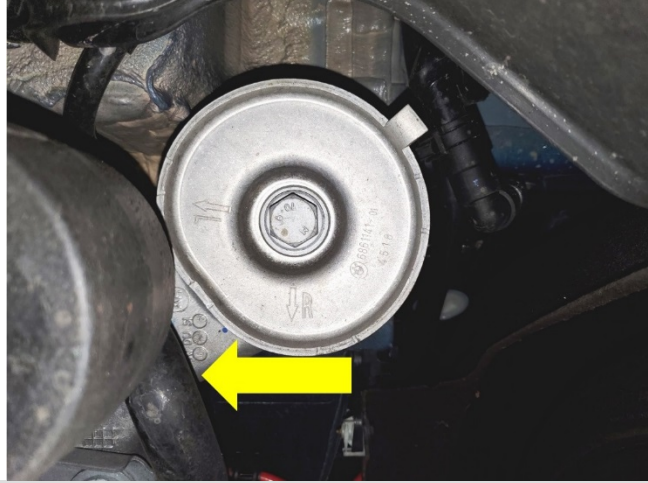
Was any visible damage to the anti-roll bar (arrow)

noticed, paint / coating damaged?

Yes: Replace the anti-roll bar as per
REP 33 55 000
