SERVICE ACTION: CHECK AND REPLACE THE LEFT REAR AXLE SHAFT

112 (i8)

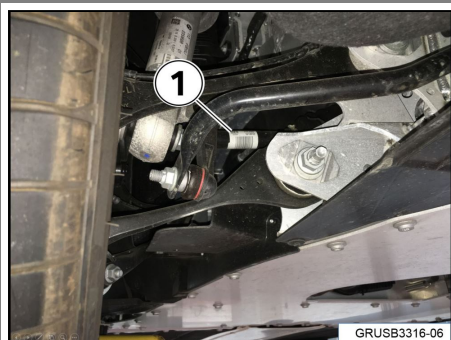
1. Raise the vehicle to access the parts label on the left rear axle (1).

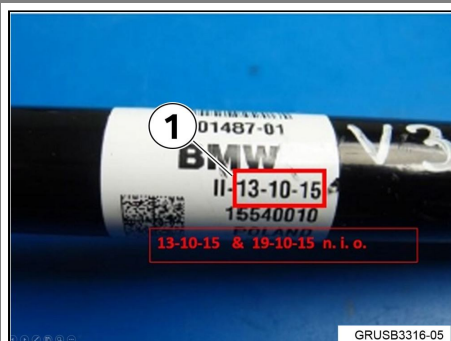
Rear axle shafts marked with production date code 13-10-15 or 19-10-2015 have been improperly manufactured.

2. Inspect the date code on the left rear output shaft (DD-MM-YY) (1). **Is the production date code either 13-10-15 OR 19-10-2015?**

YES- Replace the shaft. Follow Repair Instruction **REP 33 21 001** "Removing and installing /replacing left output shaft".

NO - Release the vehicle.
