TICKING NOISE WHILE CORNERING WITHOUT THE BRAKES APPLIED

This Service Information Bulletin (Revision 4) replaces SI B34 05 17 **dated March 2020**.

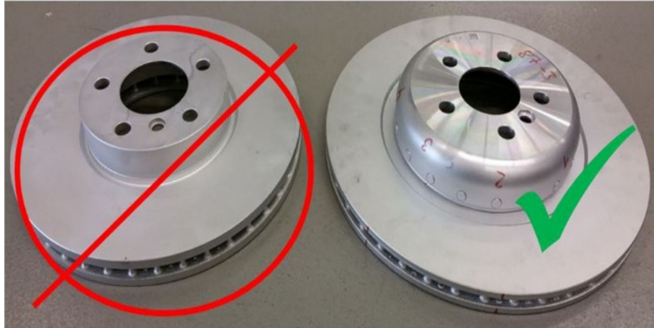
Microscopic movement of the contact interface between the inner brake disc and the wheel bearing flange on vehicles equipped with lightweight brake discs.

Are the lightweight discs (shown at right in the photo) installed on the vehicle?

Remove both front brake discs and install a friction ring between the brake disc and the wheel bearing flange.
