SERVICE ACTION: INSPECT THE RIGHT REAR WHEEL RIM AND REPLACE IF NECESSARY

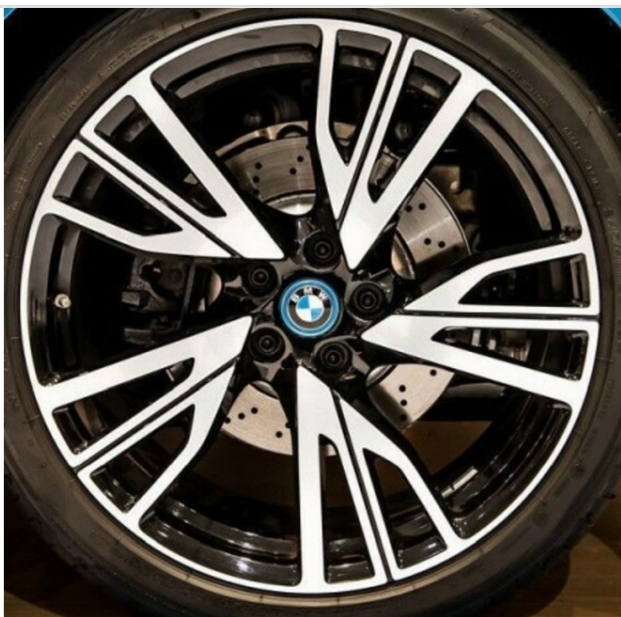
Vehicles delivered with wheel rim style 470 (shown) have directional wheels specifically for the left and right side of the vehicle.

An incorrect heat treatment has been applied to batches of the right rear rim, and may have a crack in the spoke of the wheel rim.

Error in the manufacturing process of the right rear wheel rim.

Check the right rear rim part number and batch number, replace if necessary.

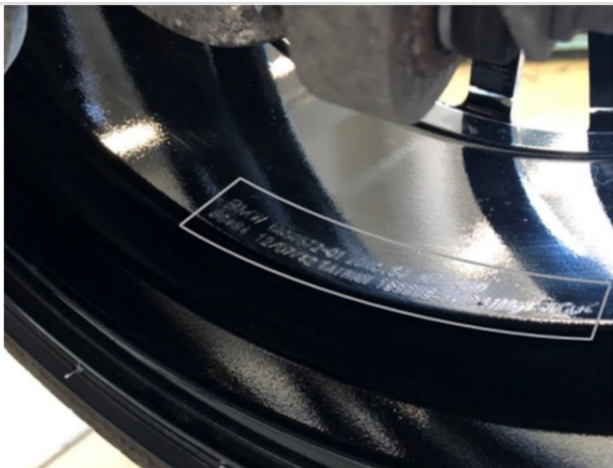
1. Verify the correct wheel style 470 installed on the vehicle.

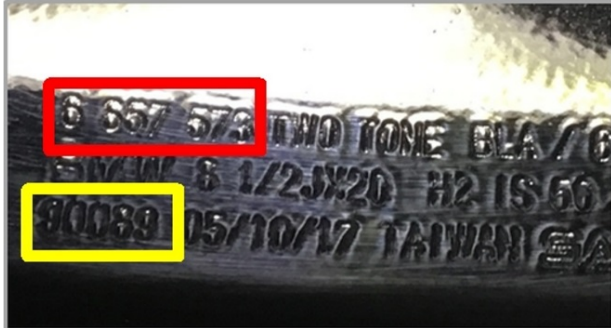
2. Raise the vehicle and locate the part number and batch number on the inside of the wheel rim.

3. Identify the part number, circled in red
 - Only part numbers 36 11 6 857 or 36 11 6 885 173 are affected
4. Is the affected part number found?
 - No-** no further action required
 - Yes-** proceed to next step
5. Identify the batch number, circled in yellow
 - Only batch numbers 90085, 90086, 90087, 90088, 90089, 90090 are affected

Yes- replace the rim as per REP 36 11 001
