G05 (X5 Sports Activity Vehicle)	G07 (X7 SAV)
----------------------------------	--------------

- Chassis stabilization warning and CCM Driving comfort restricted
- Vertical Dynamics Platform (VDP) fault code for ride height sensor implausible value.

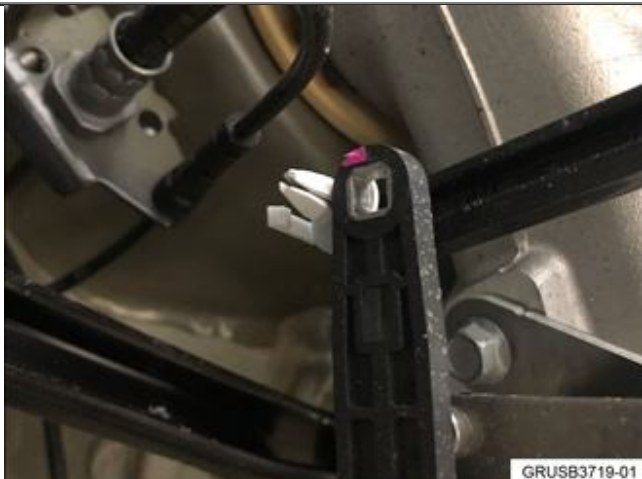
<p style="text-align: right; font-size: small;">GRUSB3719-01</p>	<p>The ride height sensor linkage became disconnected.</p>
--	--
