Service Action: PVC Weld Seam Beneath Luggage Compartment

G30 (5 Series)

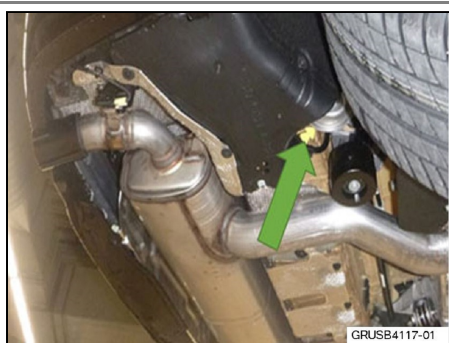
Possible water leakage into luggage compartment through PVC weld on floor.

Improperly applied PVC weld on underside of vehicle, beneath luggage compartment. Drag

1. Raise the vehicle on a lift.
2. Identify the critical area to be repaired as indicated.
