**MODEL**

E-Series	Model Description	Affected Option Code
G05	X5 Sports Activity Vehicle	Without 4UB (3 rd row seat)

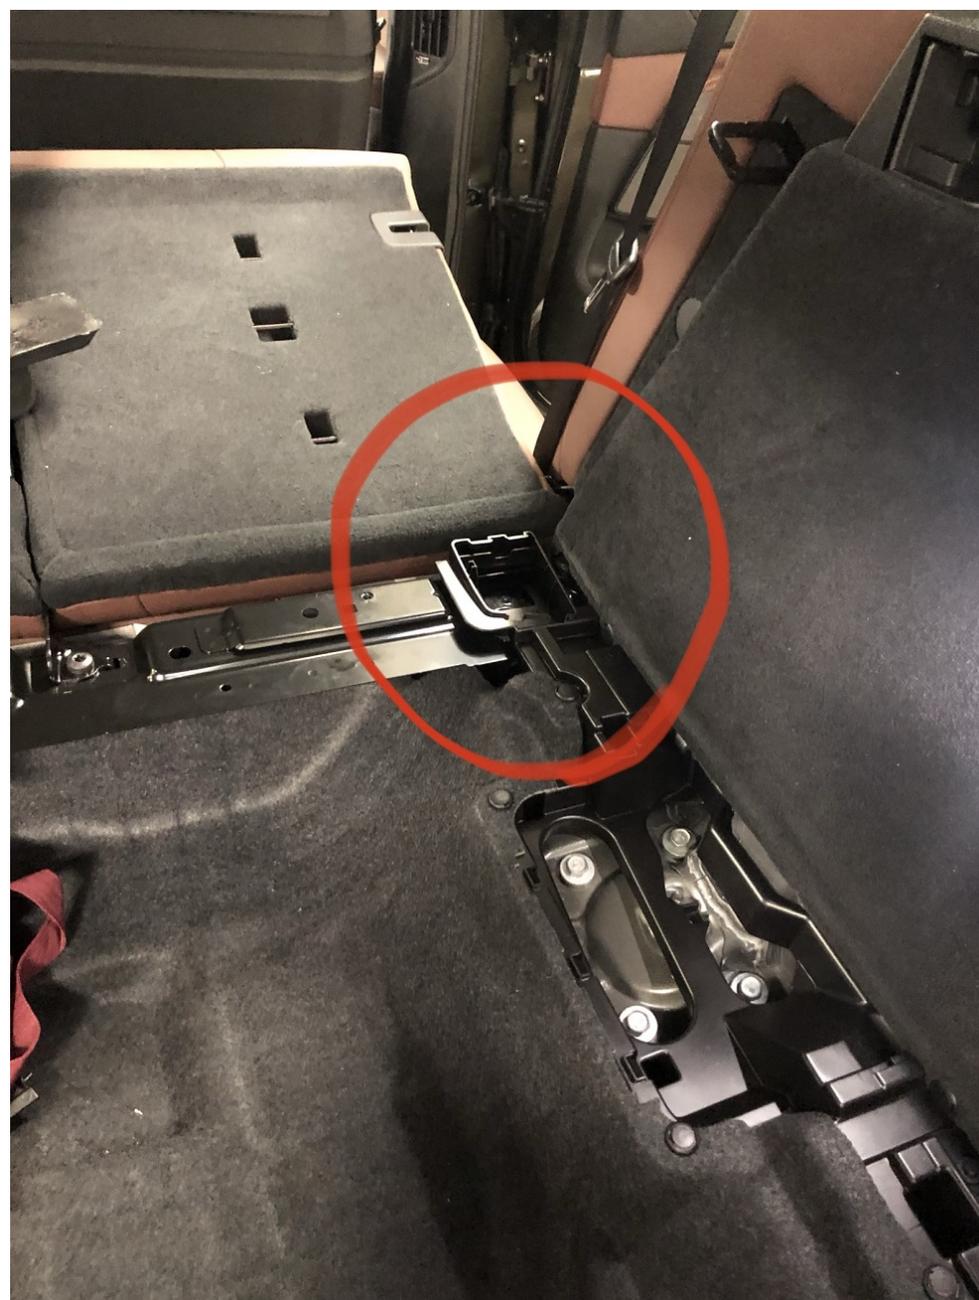
A creaking sound can be heard from the inside of the rear of the vehicle on either side, around the rear seat backrests at the floor. Most commonly, this noise is a short series (2 or 3 times) of creaking or popping sounds coming from the area shown below, during acceleration from standstill:

Interference between two sheet metal panels just below the rear seat bracket.

Rework the area with an additional weld to stabilize the two sheet metal panels.
