E-Series	Model Description	Production Date
G22	4 Series Coupe	January, 2021- January, 2022
G82	M4 Coupe	January, 2021- January, 2022

The trunk floor carpet is wet, primarily on the left side.

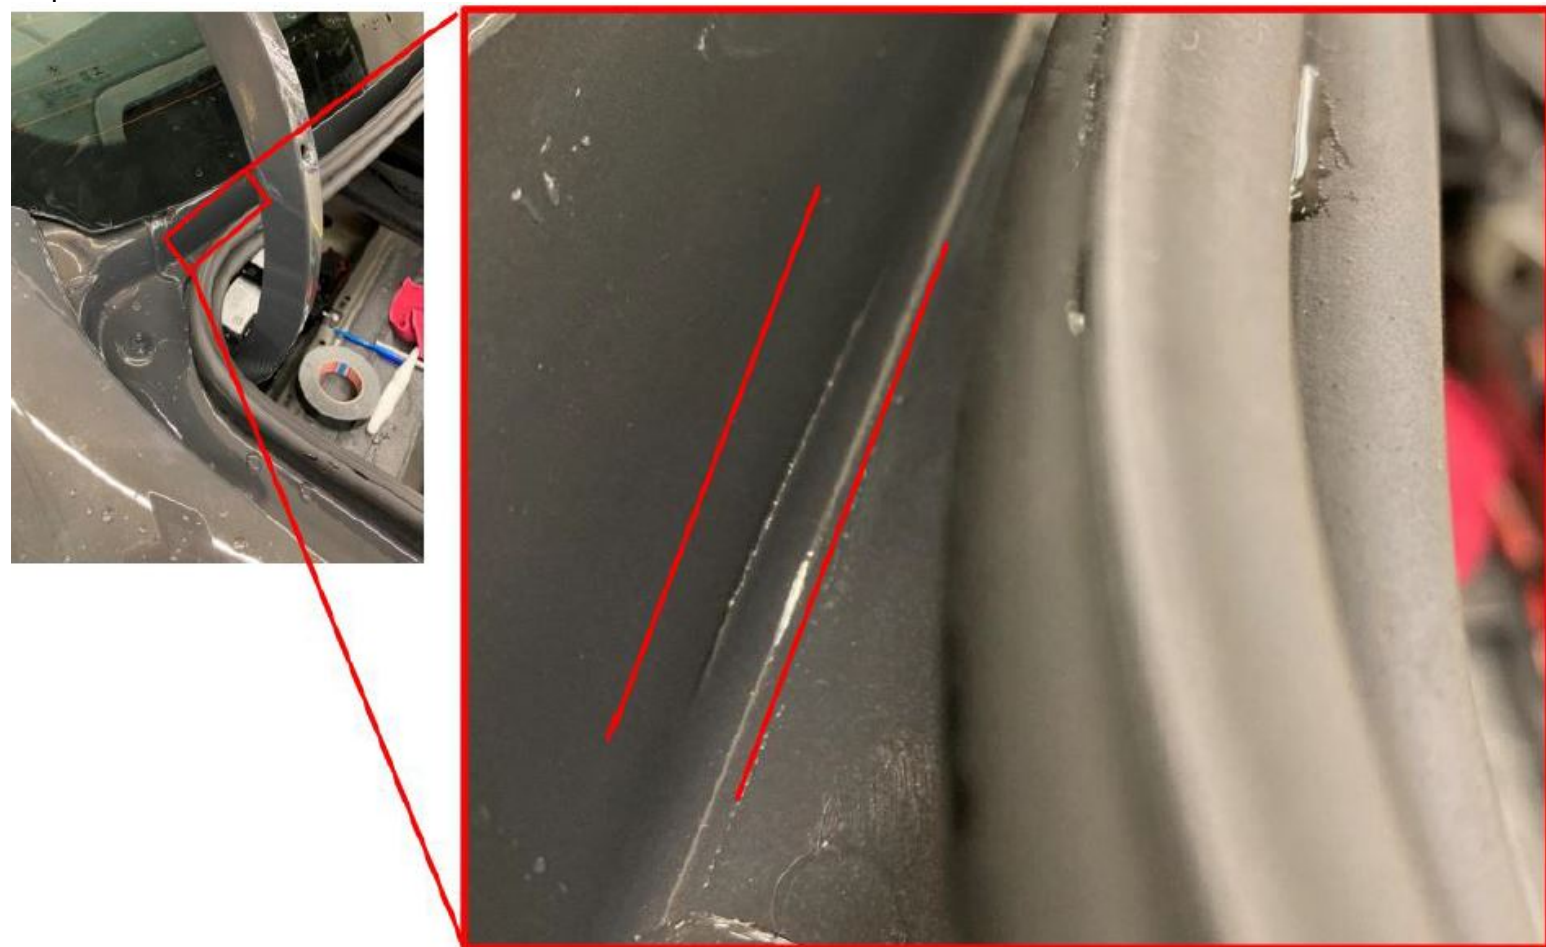
A crack in the rear window frame panel.

Inspect the area around the lower left corner of the rear window for a crack as shown below:

Repair the crack by welding.

The crack will need to be drilled at both ends and will be welded closed using one of the following methods:

1. MAG (metal active gas) welding with special care not to overheat and expand the crack
2. MIG (metal inert gas) welding using silicone bronze
3. Soft soldering/braze

After repairing the crack, the repaired area will need to be repainted and consequential repairs may apply.
