Engineering Designation	Model Description	Affected Option Code
F90	M5 Sedan	40C M Carbon Roof
G15	8 Series Coupe	40C M Carbon Roof

SITUATION

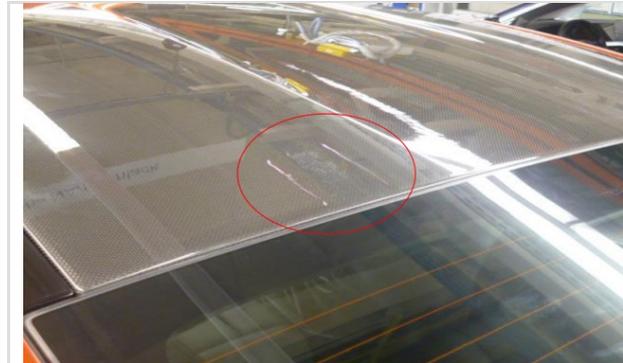
Streaks or blisters are present (circled) in the carbon fiber roof.

Note: Streaks or blistering will only be present on newer vehicles, shortly after the Bodyguard® film is removed from the roof.

Due to environmental influences, moisture can become trapped between the carbon roof and the Bodyguard® protective film used during new vehicle transportation and storage.

If these streaks or blisters do not disappear naturally in 48 hours, heat-treat the carbon fiber roof to evaporate residual moisture.

1. Expose the vehicle to direct sunlight (in summer months); or
2. Store the vehicle inside at room temperatures above 73°F.

3. Heat up the affected area slightly using a hot air blower.

Note: When using a hot air blower, the surface of the carbon fiber roof **must** be monitored using a thermometer. The surface temperature of the roof must reach at least 104°F, **but must not exceed 140°F. The hot air blower must remain at least 8 inches from the surface of the carbon fiber roof.**
