**SERVICE ACTION: CHECKING THE FRONT SIDE PANEL**

E-Series	Model Description	Production Date
G20	3 Series Sedan	February 7, 2018 – November 17, 2020

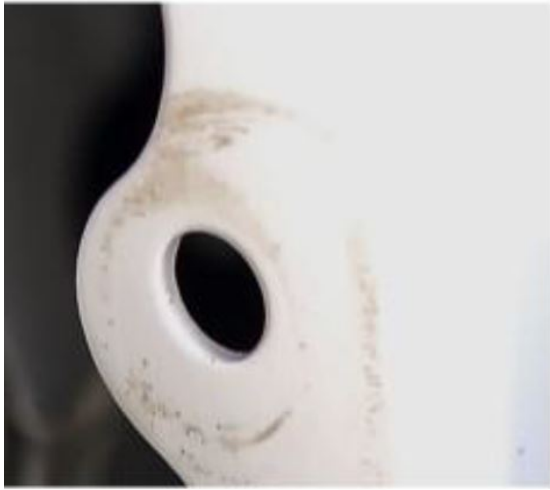
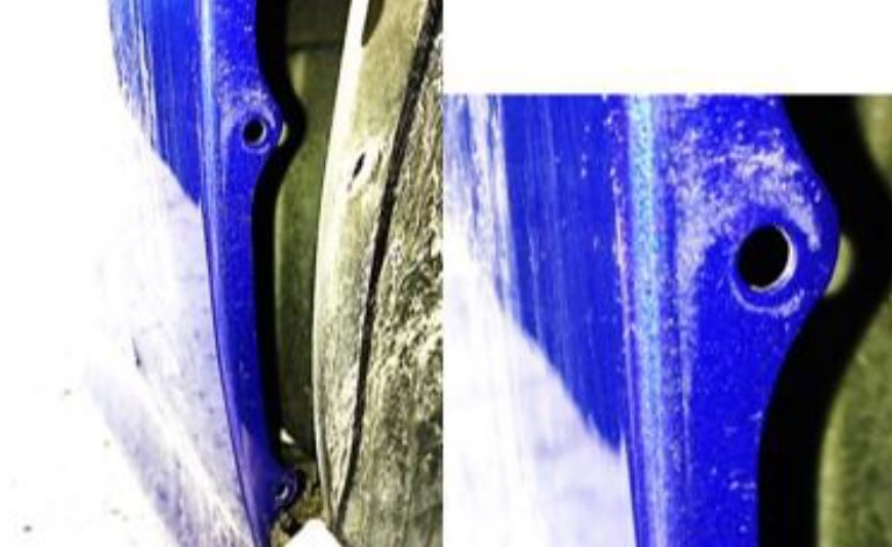
Damage version 1: Scratches in the clear coat, even over the entire area (matting of the clear coat in the area of the wheel arch liner) is permitted.

Damage version 1 (No Repair): Re-secure the fender liner using updated blind rivets. No additional repair is necessary.

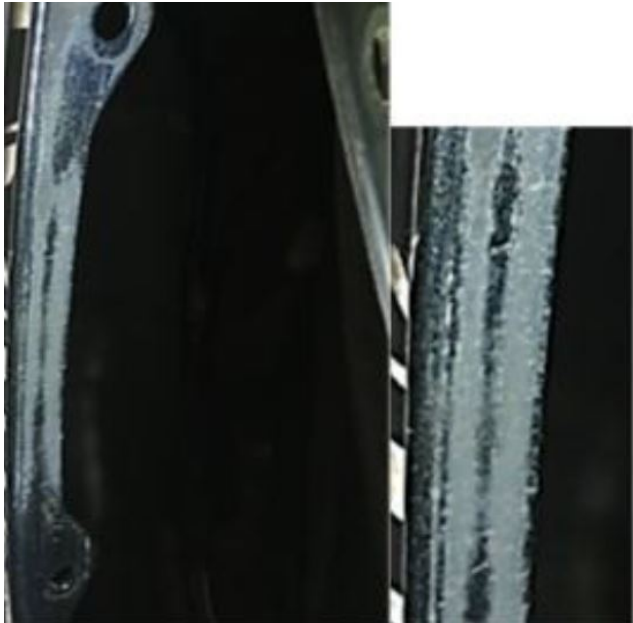
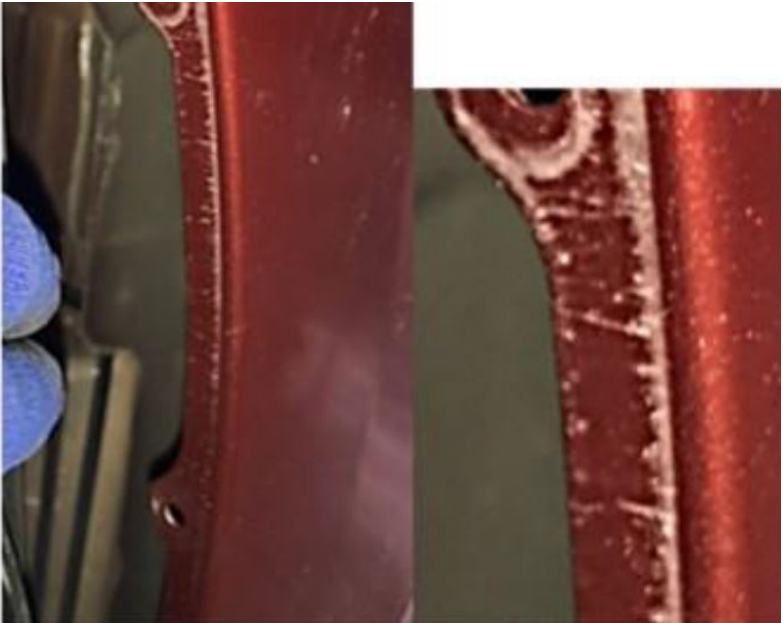
Damage version 2: Damage through the clear coat and paint. Damage must not extend all the way through to metal.

Damage version 2 (Rework): Tie back and secure the fender to keep it away from the fender. Using a clear coat touch up pen P/N 51 91 0 419 748, apply clear coat over any areas of damage. Allow the clear coat to dry completely, and re-secure the fender liner using updated blind rivets. No additional repair is necessary.

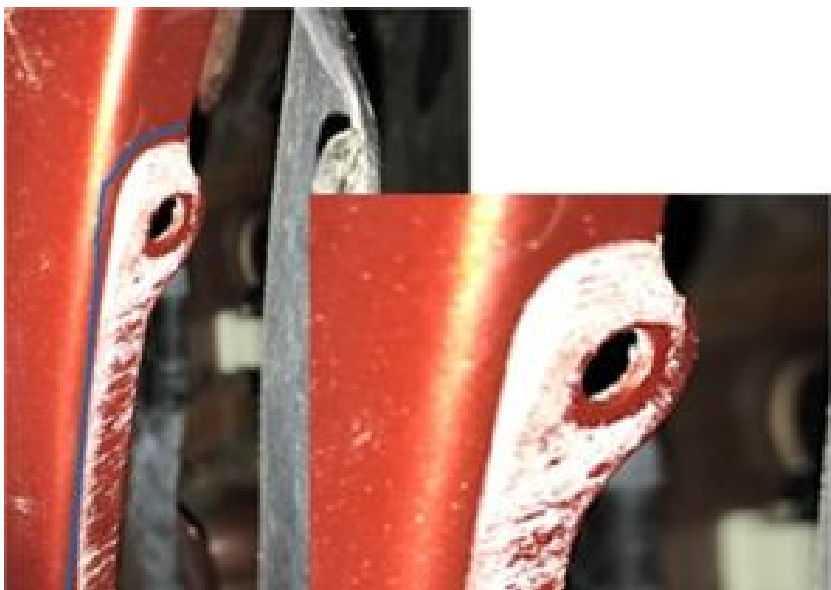
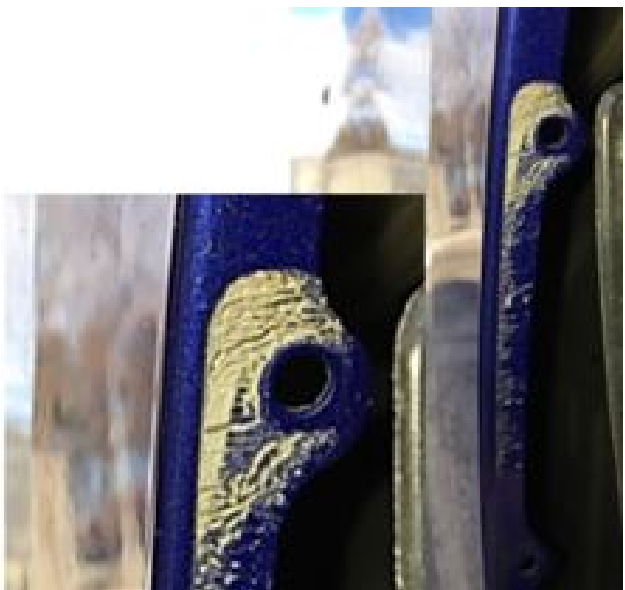
Damage version 3: Damage through the clear coat and paint down to the metal.

Damage version 3 (Repair): The small area of damage will need to be repainted by a collision repair facility. **After refinishing the damage, reinstall the fender liner and secure using updated blind rivets.** The collision repair facility can reference attachment "Attachment to B41 03 21" for additional information about how to make the repair.
